Creating Green Space
Sustainability

The Far North District Council Tree Risk Review

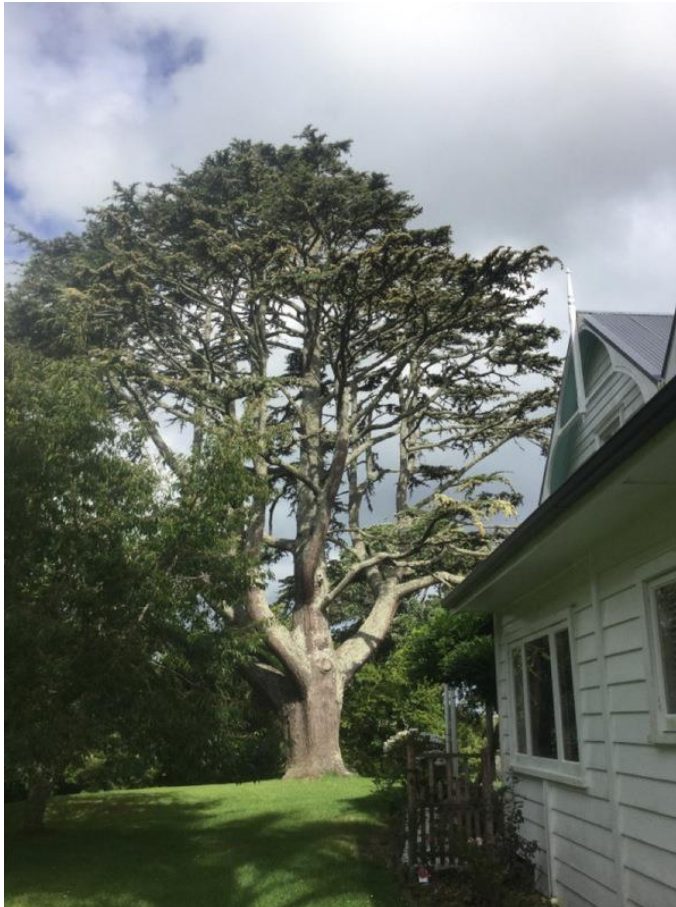
Photograph 1: Tree 21 – Whole tree

1. Single stem develops multiple leaders at 3m.
2. Tree in poor declining health shown by foliage distribution and density. Lichen throughout canopy indicating very slow growth.
3. Deadwood throughout. No indications of a history of branch failure over 80mm in diameter.
4. Decay visually evident on three buttress roots on north, west and southern sides. Using sounding hammer, decay can be traced up western portion of trunk from root flare. Annotated drawing tracing decay area undertaken and available. Minimal reaction wood occurring on some northern portions of trunk, though this is likely to be less than what is required for support. An internal assessment of wood properties will be able to determine ingress of decay.
5. Weight and growth orientation is towards north, away from building.

6. Whole tree failure onto adjacent road.
7. ARoH 1/50,000 (QTRA guideline = tolerable).

8. Given the weight distribution and that the affected buttress roots are generally on the west of the tree, whole tree failure will be in a northerly direction, away from the main

dwelling. The direction of whole tree failure due to root decay will likely fall towards the road. The road is approximately 25m from base of trunk, though confirmation is required. If so, failure is unlikely to result in contact with the road.

9. The health and condition of the tree (along with species characteristics) limits reduction pruning as a mitigation measure, as any pruning is likely to increase the tree's rate of decline.
10. The health of the tree can be improved by introducing soil improvement measures. Improving the health of the tree will allow it to add reaction wood near the wound.
11. Undertake an internal decay assessment. This can be undertaken using specialised equipment such as a Picus tomography application. Using an internal assessment of decay, can establish the extent of decay and possible likelihood of failure.
12. Install bracing / guideline/s from the ground to the tree, effectively controlling its failure direction or holding in place, which will be done concurrently with health improvements.
13. Removal the tree and replace as a final option.

14. As soon as practical.

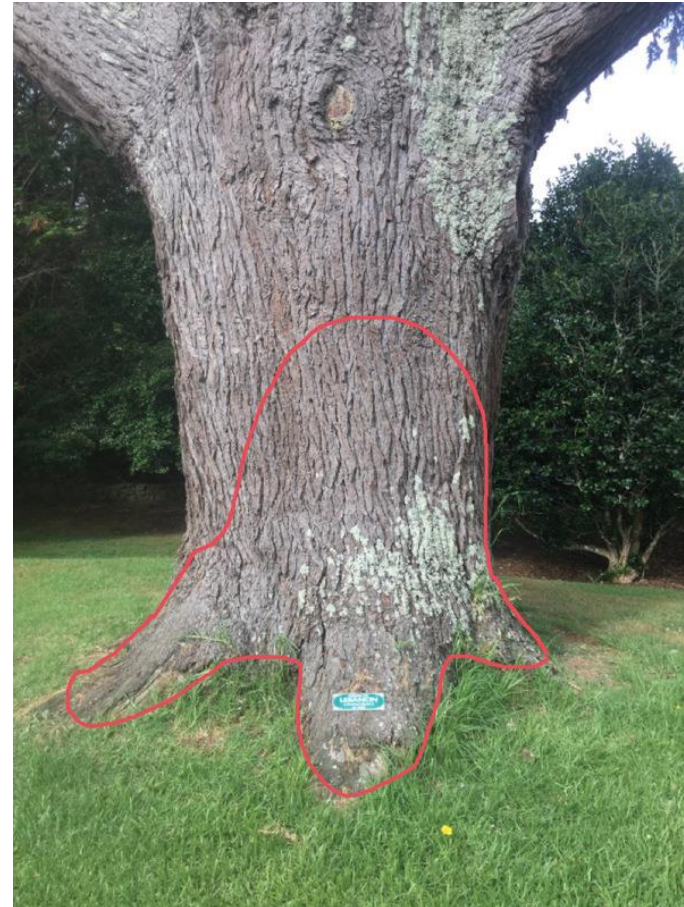
Photograph 2: Tree 21 – annotated photo of probable decay cavity behind bark

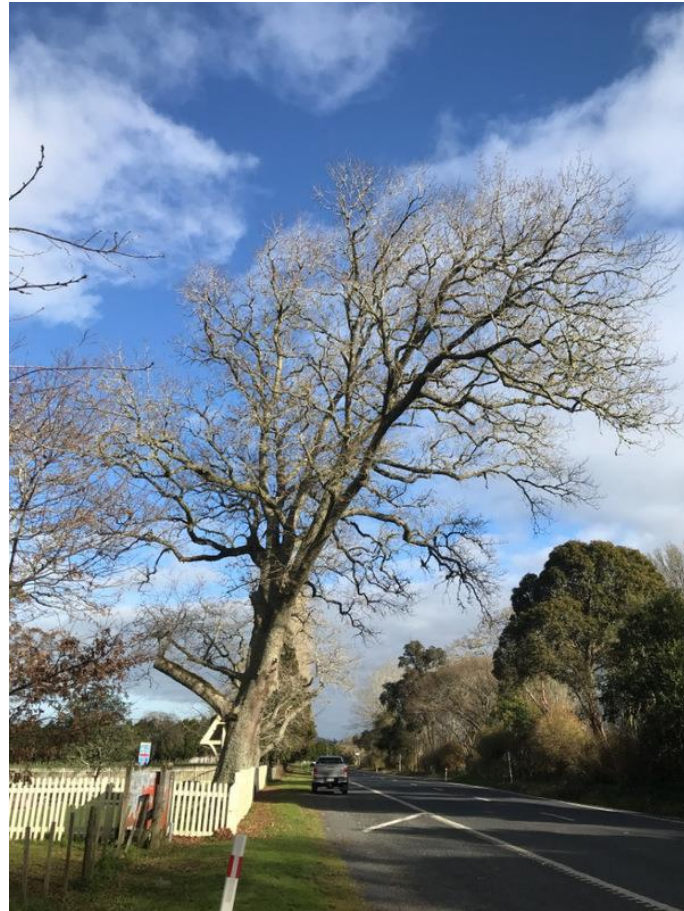
Photograph 3 – Tree 25a

4. Whole tree failure to road.
5. ARoH 1/400,000 (QTRA guideline = tolerable).

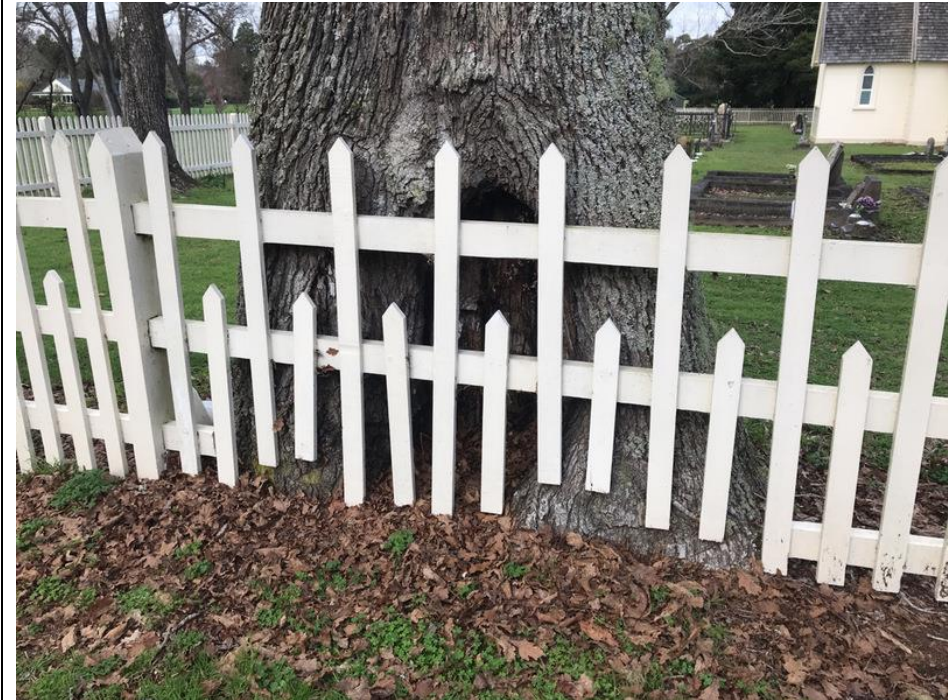
Photograph 4 – Tree 25a. Cavity.

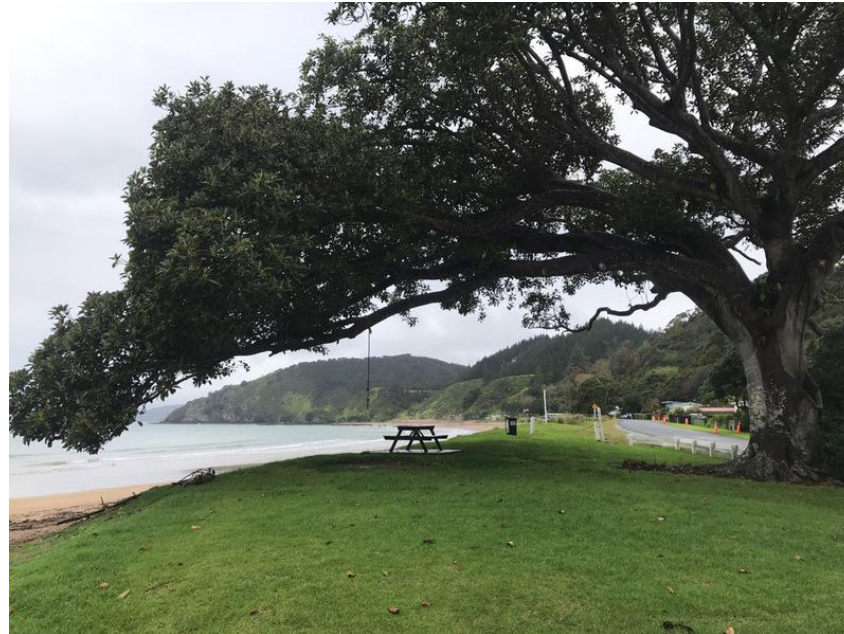
5. Lateral branch failure onto park bench.
6. ARoH 1/100,000 (QTRA guideline = tolerable).

7. The extended, heavily weighted laterals are overhanging a park bench. Given the loading of the laterals and that the tree has shown a propensity of lateral branch failure, risk mitigation could be undertaken.

Photograph 5: Tree 49. Extended lateral branches over bench seat.

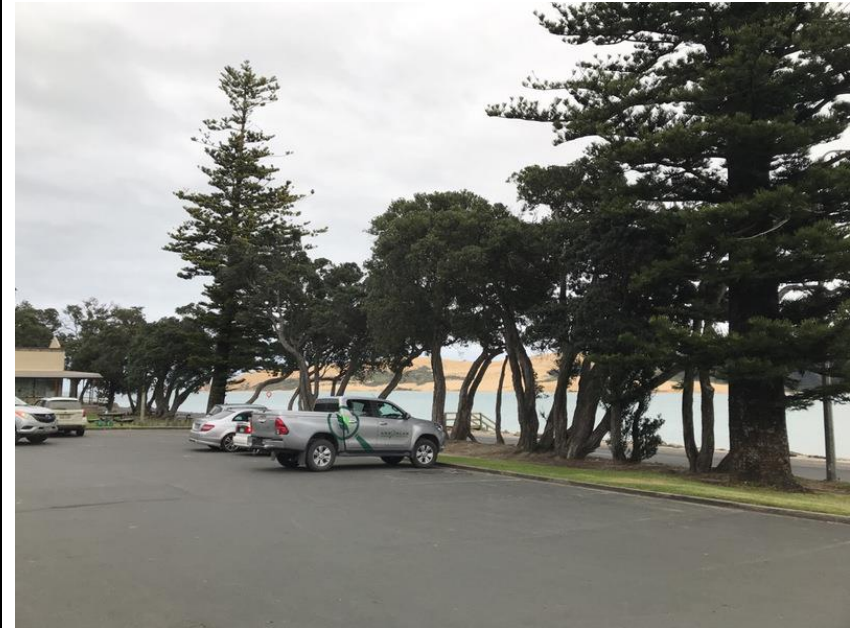
Photograph 6: Tree 92

14. Deadwood failure above carriageway.
15. ARoH 1/50,000 (QTRA guideline = tolerable).

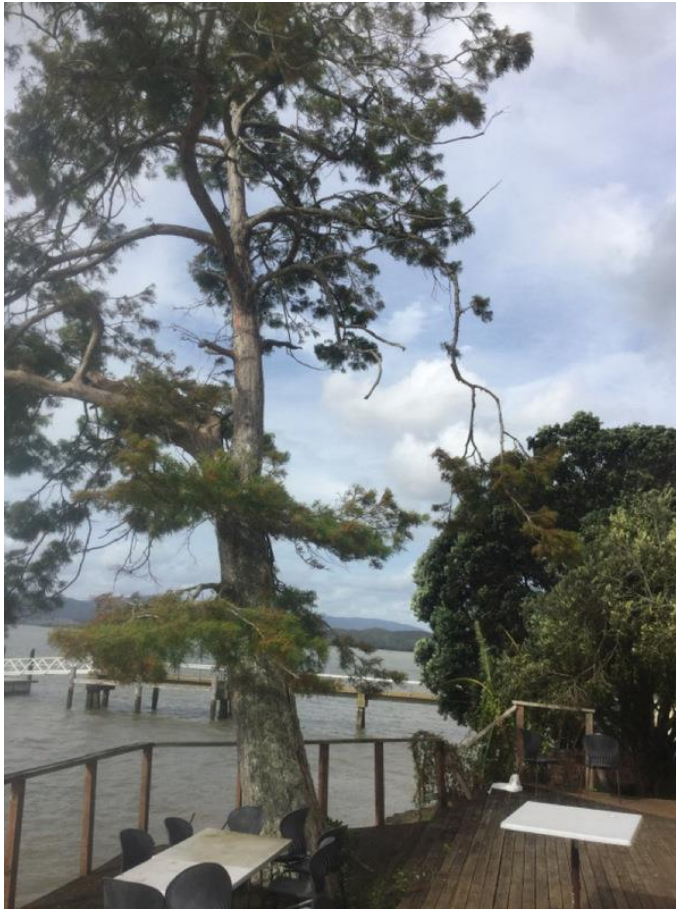
Photograph 7: Tree 100a. Whole tree

7. Dead branch failure and contact to persons on deck.
8. ARoH 1/500,000 (QTRA guideline = tolerable).

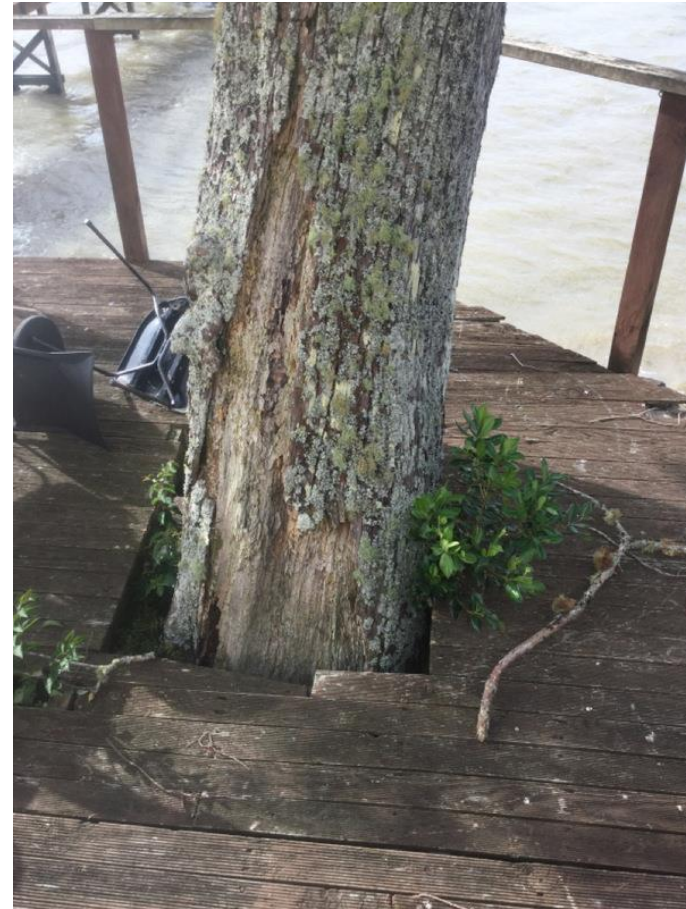
1. Extensive decay from ground level up tension side of tree's trunk. Potentially 1/3 circumference effected.
2. Some dead branches in canopy above deck area. Canopy health may or may not be reflective of root and base decay issues.
3. Stem and tree failure away from seating area, which equates to a low target rating for whole tree failure as the fall / target area for whole tree failure is onto the foreshore.
4. Highest risk of harm from dead branch failure to person located on deck.
5. Centre of trunk approx. 4m to edge of Seawall – check ownership.
6. Deck generally of poor condition. Seating area under the tree is, in my opinion, undesirable in its current condition (therefore human occupation likely to be limited).

Photograph 8: Tree 100a. Decay on tree trunk
