Geotechnical Investigation Report

Te Mataora Project – Greenacres Drive, Kawakawa

15 February 2023

Job No. NL220114

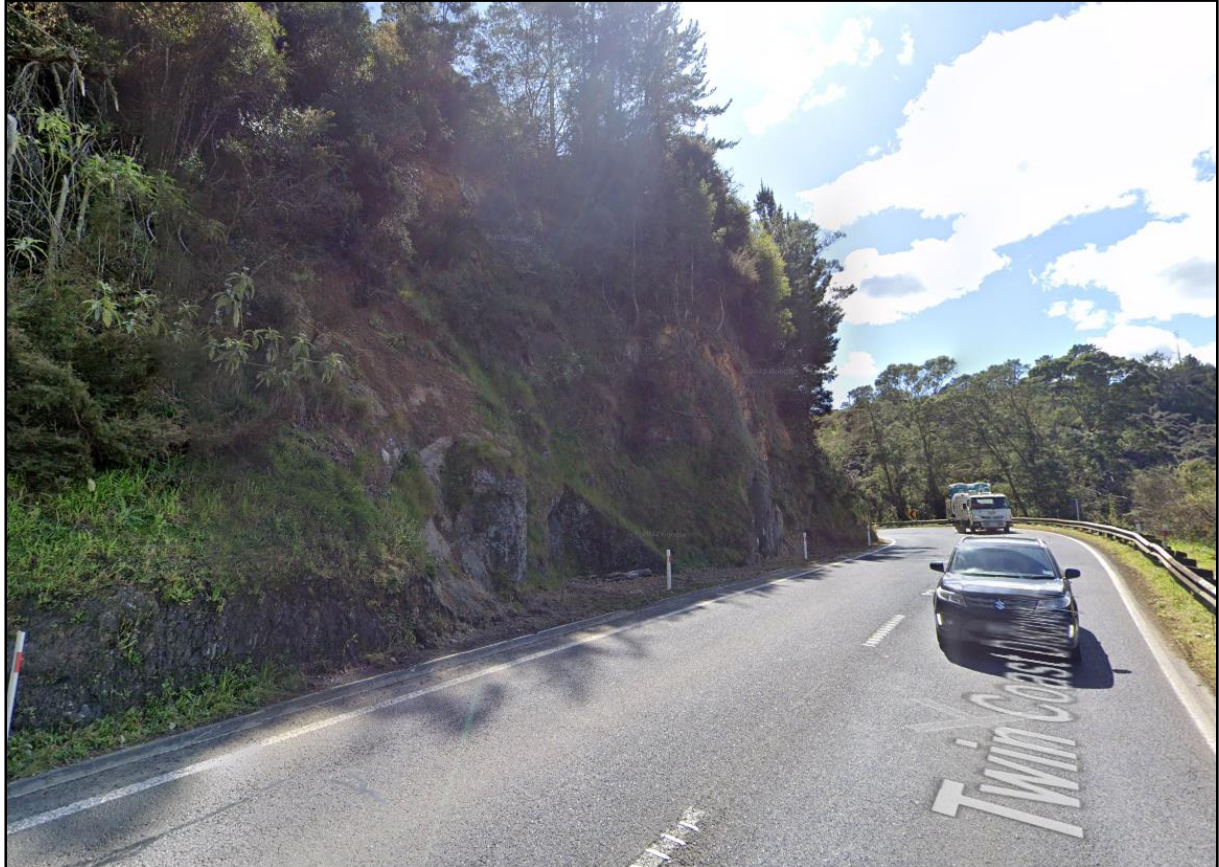
Figure 7: Slope Adjacent to SH1 (South-East of Site) – Looking North-East (Source: Google Maps)

At the south-eastern end of the site, within the Stage 3 area, the ground surface descends towards the south/south-east at inclinations in the order of approximately 8° to 20°. A steeply inclined slope is present to the east of the site, which slopes down to SH1 (towards the south-east) at inclinations generally in the order of approximately 25° to 40°, becoming extremely steep immediately adjacent to SH1 in some areas

(see Figure 7 below). As shown in Figure 7, Waipapa Group rock appears to outcrop at the base of the slope adjacent to SH1. The crest of this steeply inclined slope runs approximately parallel to the south-eastern site boundary.

At the time of our investigation no visual evidence of major, deep-seated instability was identified within the site, however the steeply inclined slope beyond the south-eastern site boundary could not be safely accessed during our investigation.

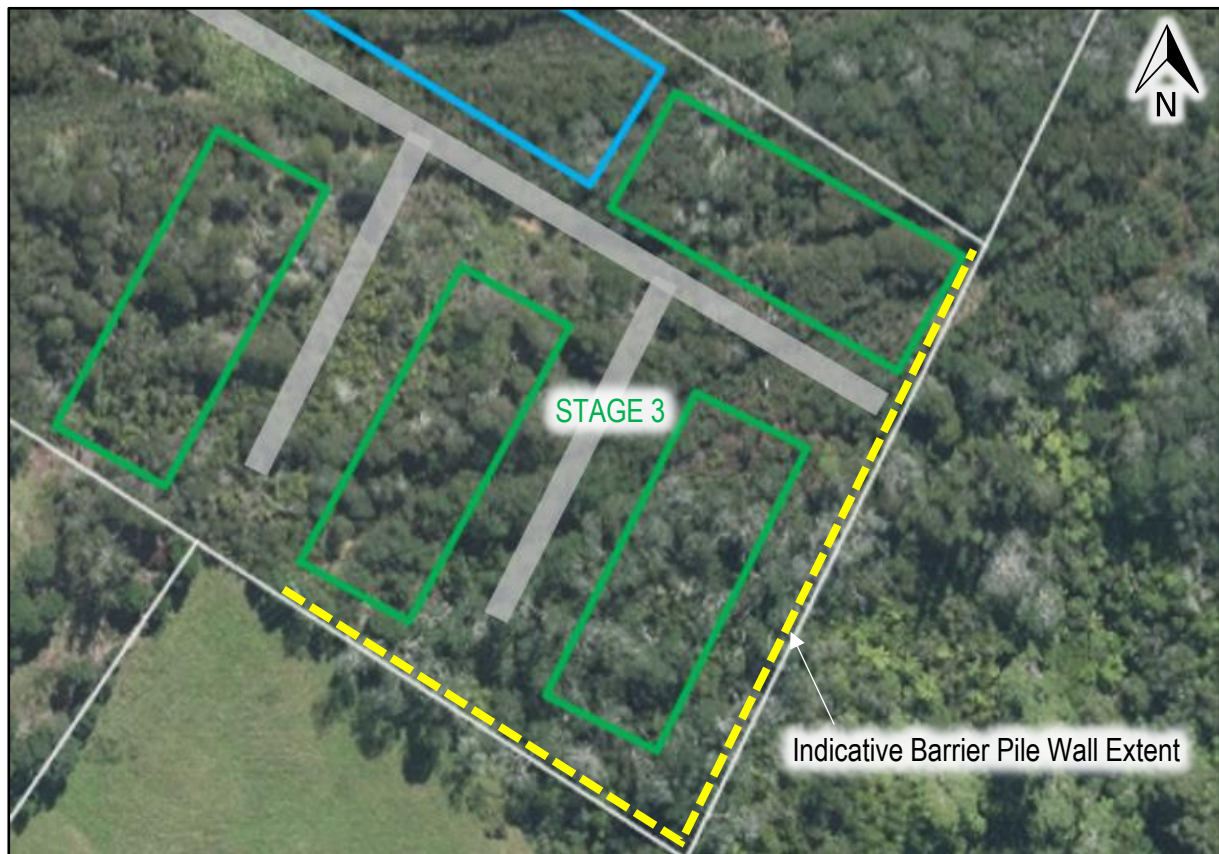
Figure 8: Indicative Stage 3 Barrier Pile Wall Extent

The potential failure surfaces shown within sections A-A' and B-B' are primarily located beyond the south-eastern site boundary, over the steep slope which descends to the south/south-east towards SH1. Failure surfaces also extend into the site, however are limited to the residual weathered Te Kuiti Group soil mantle.

The two proposed south-eastern-most buildings within the Stage 3 development area (see Figure 5) will either:

- A) Need to be located away from any potential failure surfaces, with Building Restriction Zones identified after additional investigation and assessment,
 - B) Have specifically designed foundations that comprise deep piles embedded into Waipapa Group rock, or
 - C) Be located on building platforms that are retained by a barrier pile/palisade wall (mostly likely incorporating tie-back anchors) specifically designed to account for potential downslope instability. Such walls would need to be located along the south-eastern site boundary, and partially along the southern boundary where instability is expected (see Figure 8.0 below).
-

In addition, buildings located on/near ground inclined steeper than 1V:3H will need to have foundations designed to account for downslope soil creep movement. Soil creep is a shallow 'local' movement and is a separate issue to the deep 'global' issues discussed above. We anticipate the buildings will be located on terraced and/or retained level building platforms, in which case design to account for soil creep will not be required.

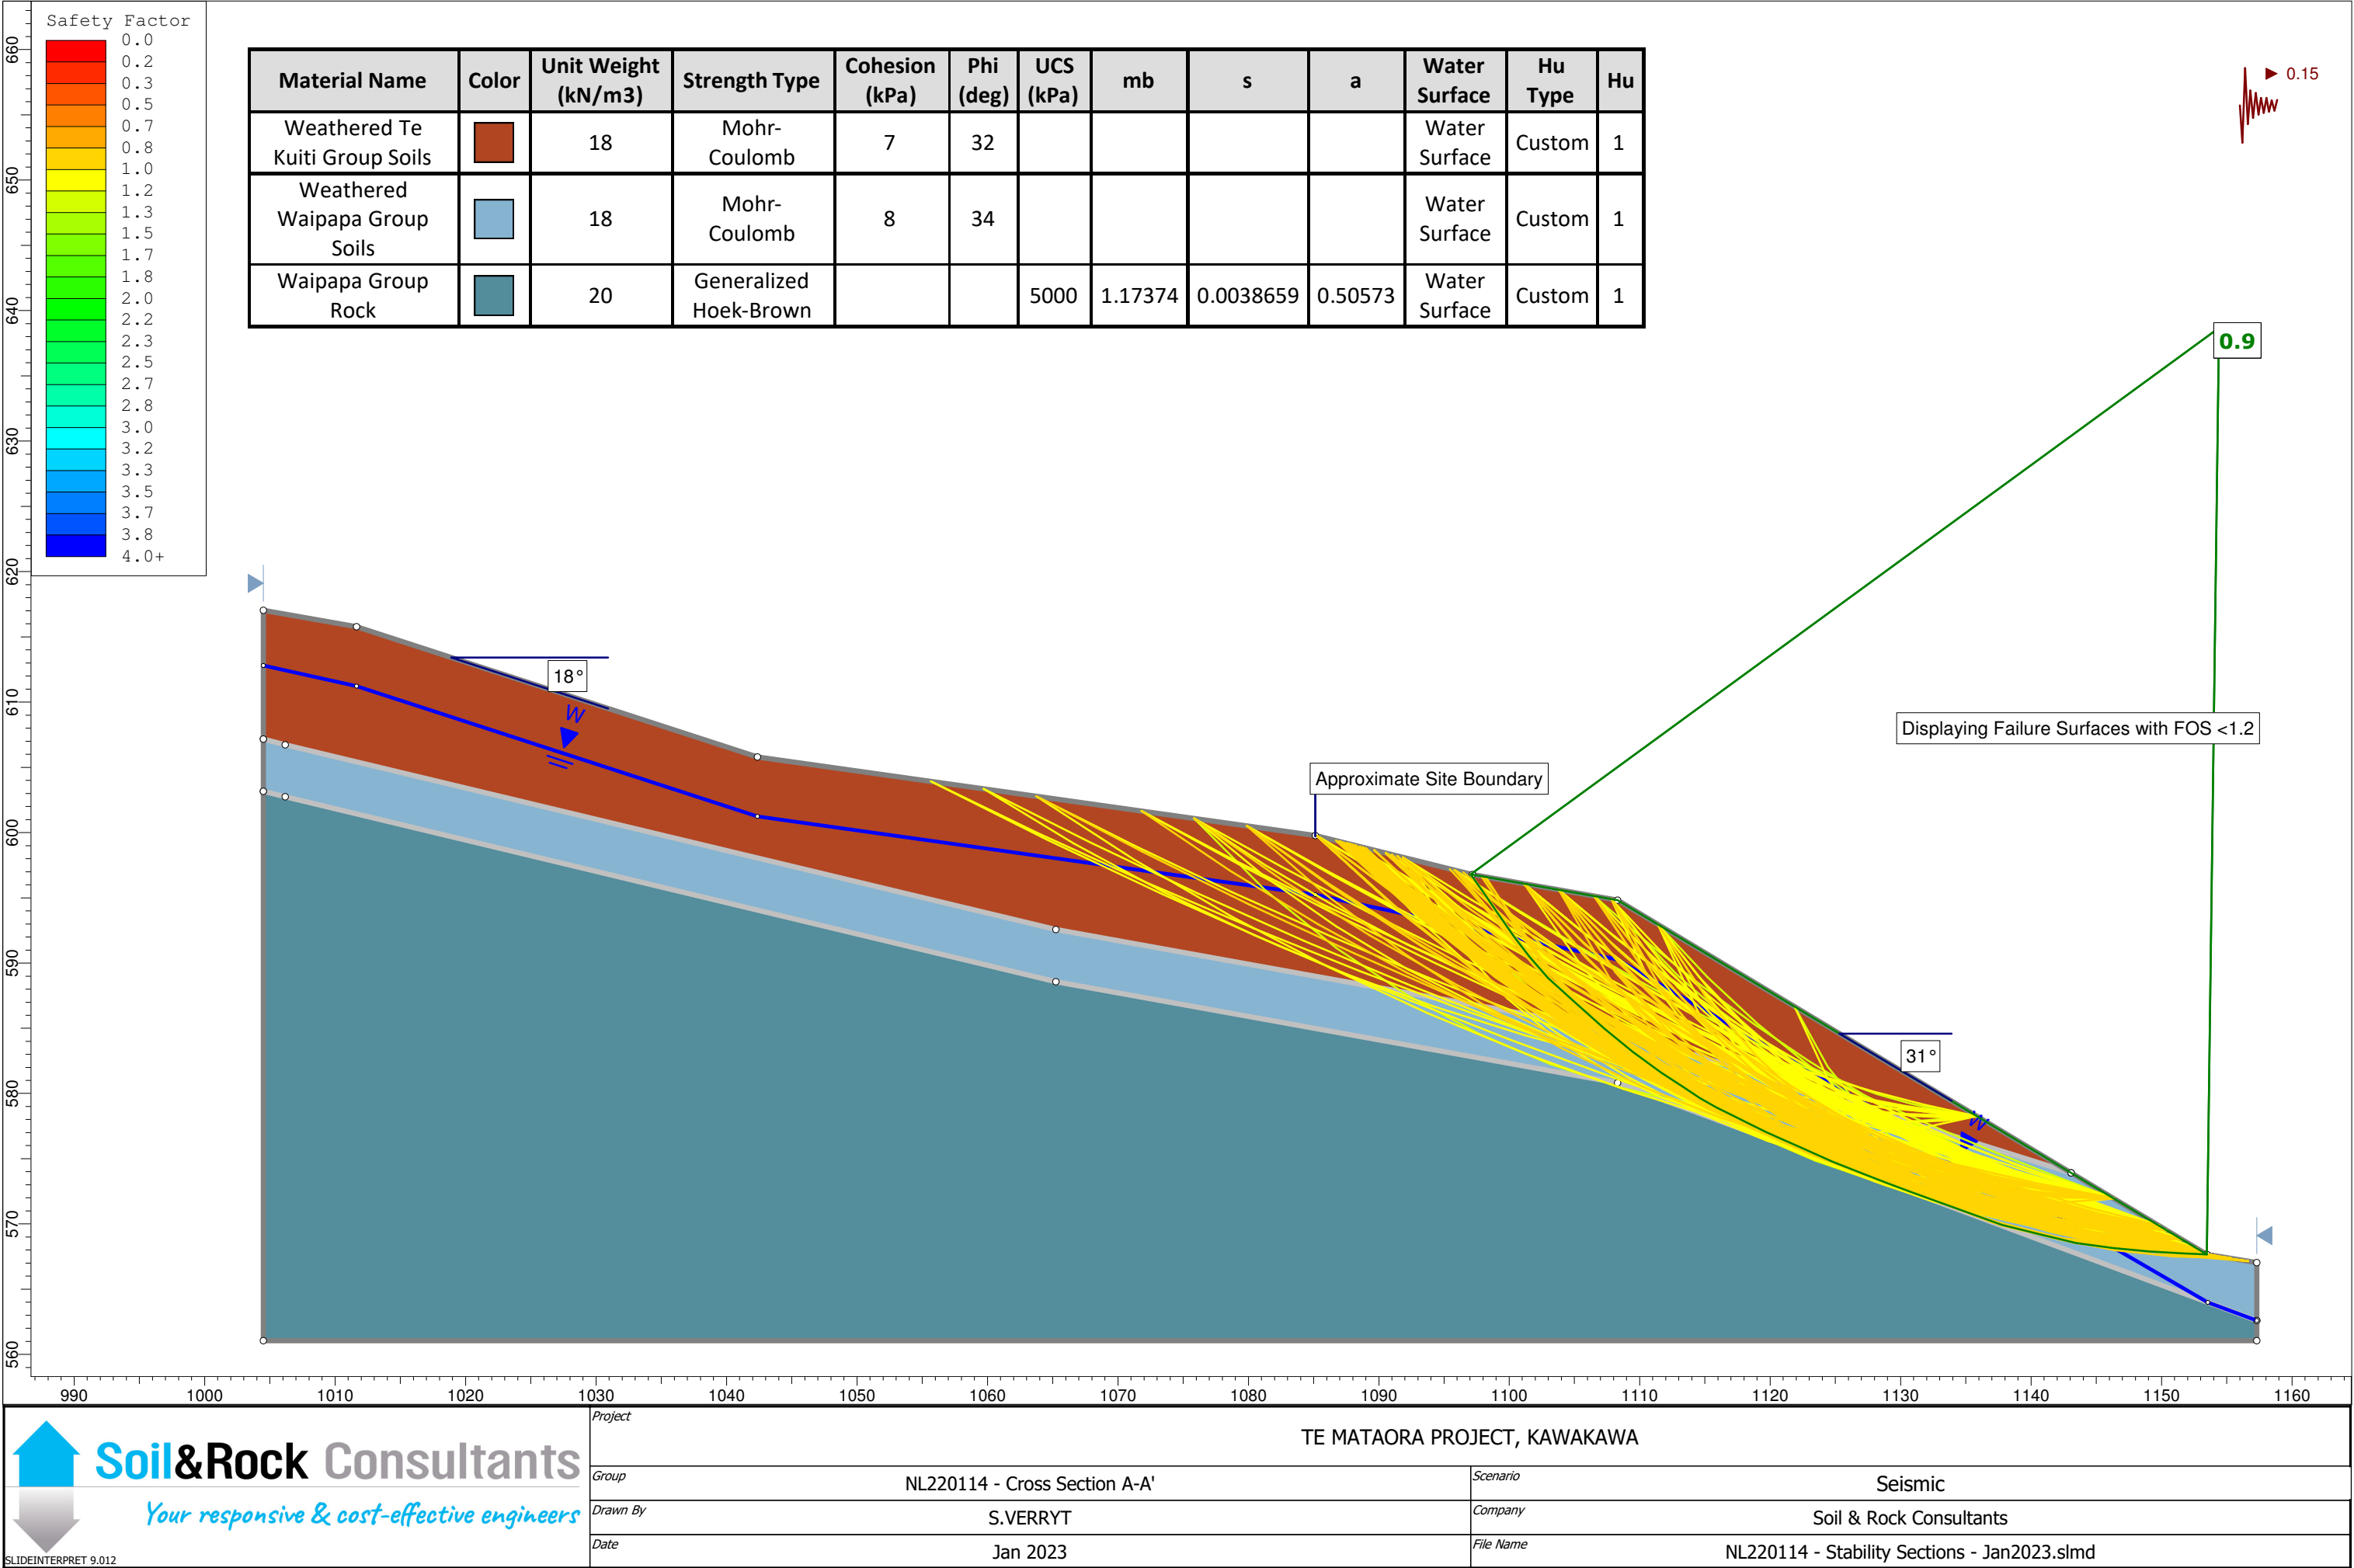
Project	TE MATAORA PROJECT, KAWAKAWA		
Group	NL220114 - Cross Section A-A'	Scenario	Seismic
Drawn By	S.VERRY	Company	Soil & Rock Consultants
Date	Jan 2023	File Name	NL220114 - Stability Sections - Jan2023.slmd

Section	Modelled Conditions	Global Factor of Safety	
		Required	Calculated
A-A'	Inferred Long-Term Groundwater	1.5	1.1
	Extreme (Worst Credible) Groundwater	1.3	0.9
	Seismic Loading	1.2	0.9
B-B'	Inferred Long-Term Groundwater	1.5	1.2
	Extreme (Worst Credible) Groundwater	1.3	1.1
	Seismic Loading	1.2	0.9

The global minimum FOS results in Table 5 are less than the Auckland Council requirements for each analysed condition – refer to attached Stability printouts (Appendix C).
