1. SUMMARY

Claim for the Month of March 2024

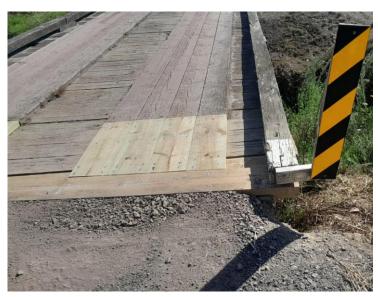
Wallis Road Bridge Repair

Our signs crew carried out some emergency repairs on Wallis Road bridge after significant damage was caused to the brdge structure.

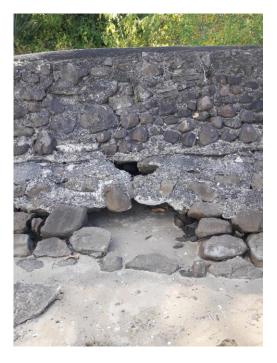
Rawene Seawall Repair

Our concrete crew made repairs on the Rawene Seawall on Clendon Esplanade, after storms last year caused erosion and undermining. After multiple temporary repairs, we were finally able to time the tides and the concrete pump to complete the job.

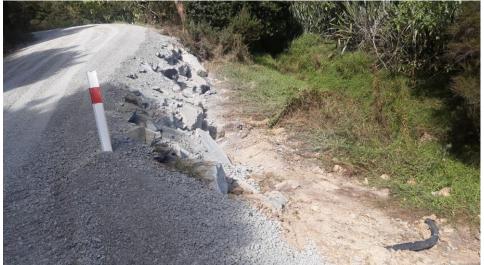
Kaka Road Before /After

Darroch Contracting completed a large drainage project on Waimate North Road, and our Renewals team completed an under slip on Kaka Road. Northland Tree works completed a large job on Florence Ave in Russell, one of the gifts left behind from Gabrielle.

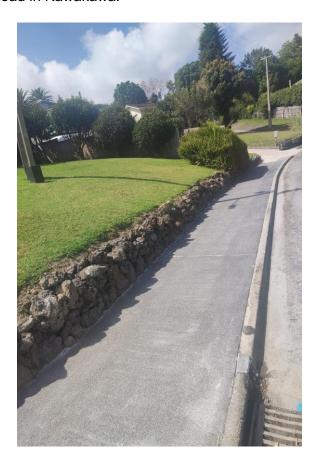
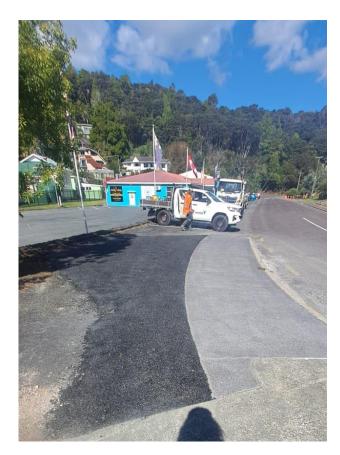
Yorke Road /Joyces

The concrete crew have completed footpath renewals on Tahuna Rd, Joyces Rd and Williams Road in Paihia. They are currently working on Hawke Drive in Haruru Falls and then will jump over to Whiteman's Road in Kawakawa.

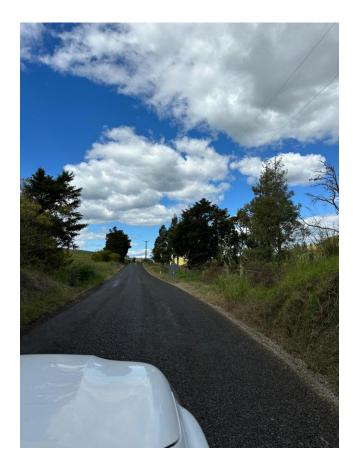
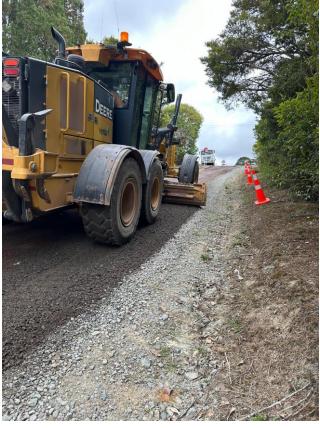
- Happy Valley Road RP25-1951. Road received approximately 1120m3 of new wearing course.
 This followed on from sections of build up that were carried out last year after cyclone Gabrielle.
- Orira Road RP 1191-3800. Build up and wearing course on multiple sections of road totalling approximately 1800m3 aggregate.

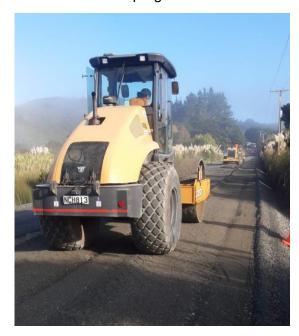
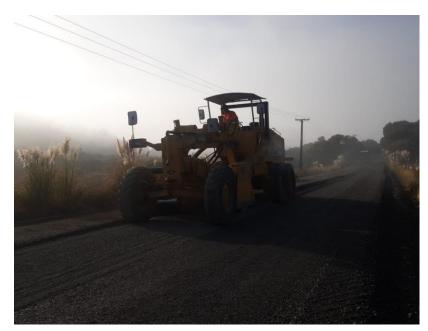
Paroa Bay Road - Russell

The culvert crew switched things up this month and have been working on a rehab on Paroa Bay Road, Russell. The team completed shoulder and pavement strengthening in March and the site was cement stabilised before easter. Sealing will tie in with the remaining reseal sites in Russell which will complete our 23/24 reseals programme.

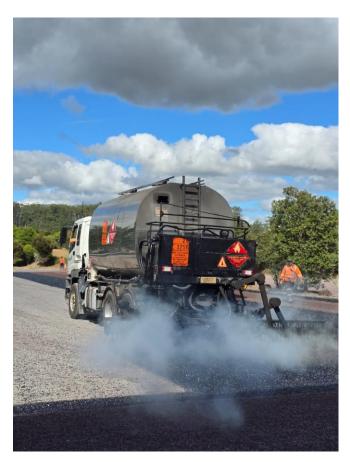
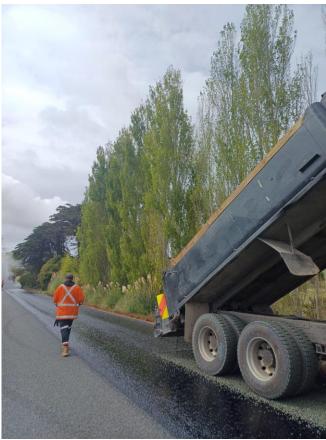
Kerikeri Rugby Club / Cumber Road

The focus in March has been KDC reseals with 8km (54465.42 m2) completed in the area. The plan for the sealing team is to return to complete all possible FNDC reseals early April focussing on Russell, where the remaining sites are. It looks like there may possibly be some additional sites added to the programme which we will aim to pursue while the weather continues to allow resealing activities.

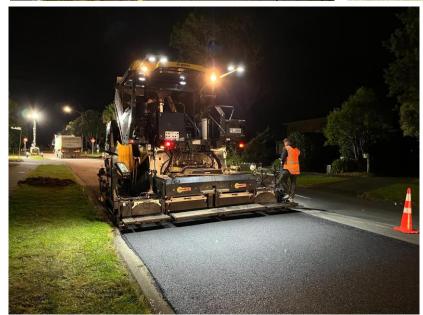
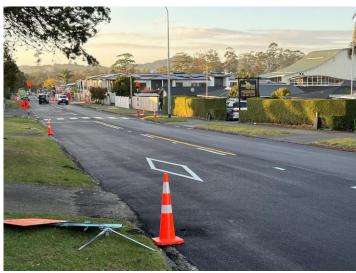
Cobham Road Kerikeri

In late March we started the Asphalt resurfacing of Cobham Rd in Kerikeri. This work was carried out under night shifts and will continue until mid-April. This project involves approximately 10,000m2 of surfacing works along with some additional drainage and shoulder works down towards Kerikeri Inlet Road. A big thank you to the residents who have been very patient with the late night noise and disruption for the last couple of weeks.

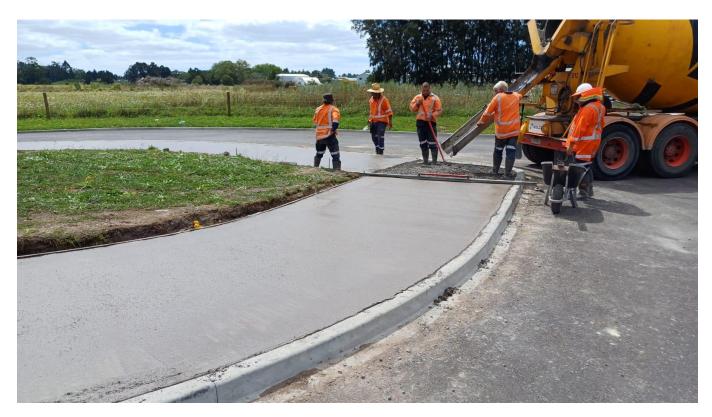
Windermere Roundabout

The crew was asked to add a concrete footpath to the interior of the roundabout at the cul de sac down Windermere. This was to add more stability and protection to the kerb from heavy vehicles.

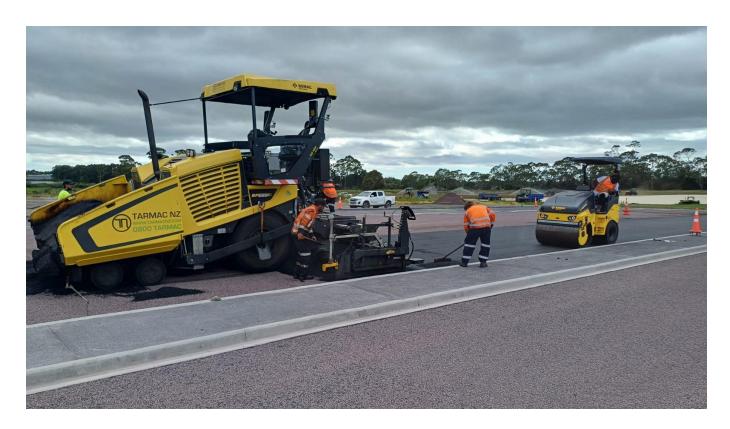
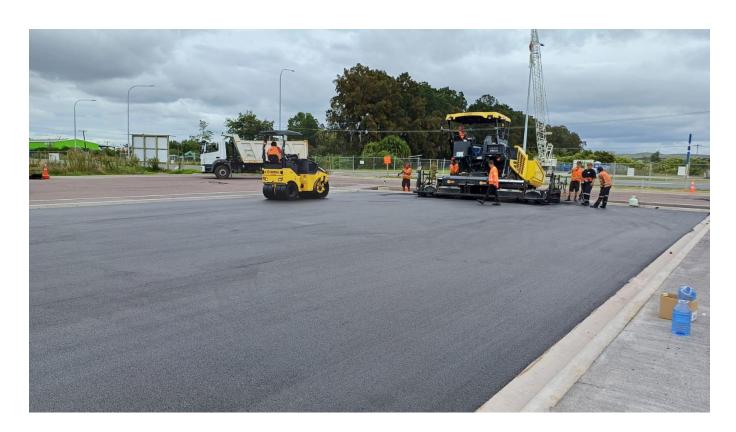
Waipapa Sports Complex

A push on the sports complex saw the membrane and then asphalt laid. The site is nearing completion with a set of raised ramps and line marking to finish off. There will be other works to follow including bollard installation and more footpath work on the outside perimeter leading to the sports fields.

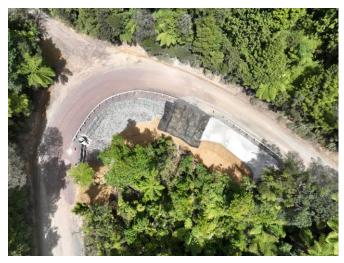
Waikare Slip Repair

The Waikare slip repair was completed on time and the finished product looks great. The result creates a much wider safer road for the community. The site was left in a tidy state with little disruption to the local community, and everyone involved should be proud of what has been achieved.
