Geotechnical Investigation Report  
Proposed Dwelling Extensions, Pool & Shed  
55 Kingfisher Drive, Kerikeri  
Lot 2, DP 311542 & Lot 4, DP 317854  
For  
Ian & Vicki Smith

*Haigh Workman reference 25 023*

March 2025

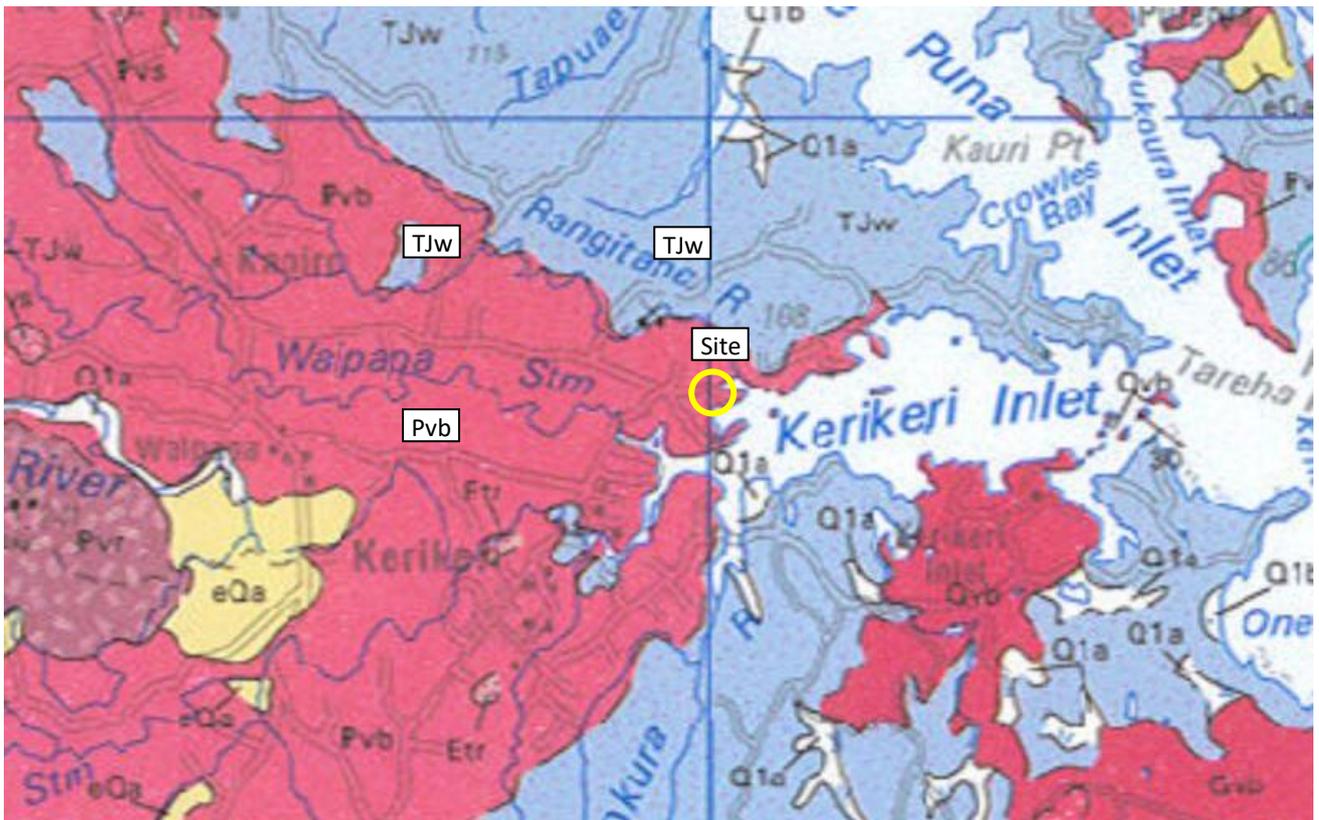
Figure 2: Geological Map (Whangarei Map, 1:250,000)

An extract of the geological map is shown in Figure 2 below, with geological units presented in Table 1 below.

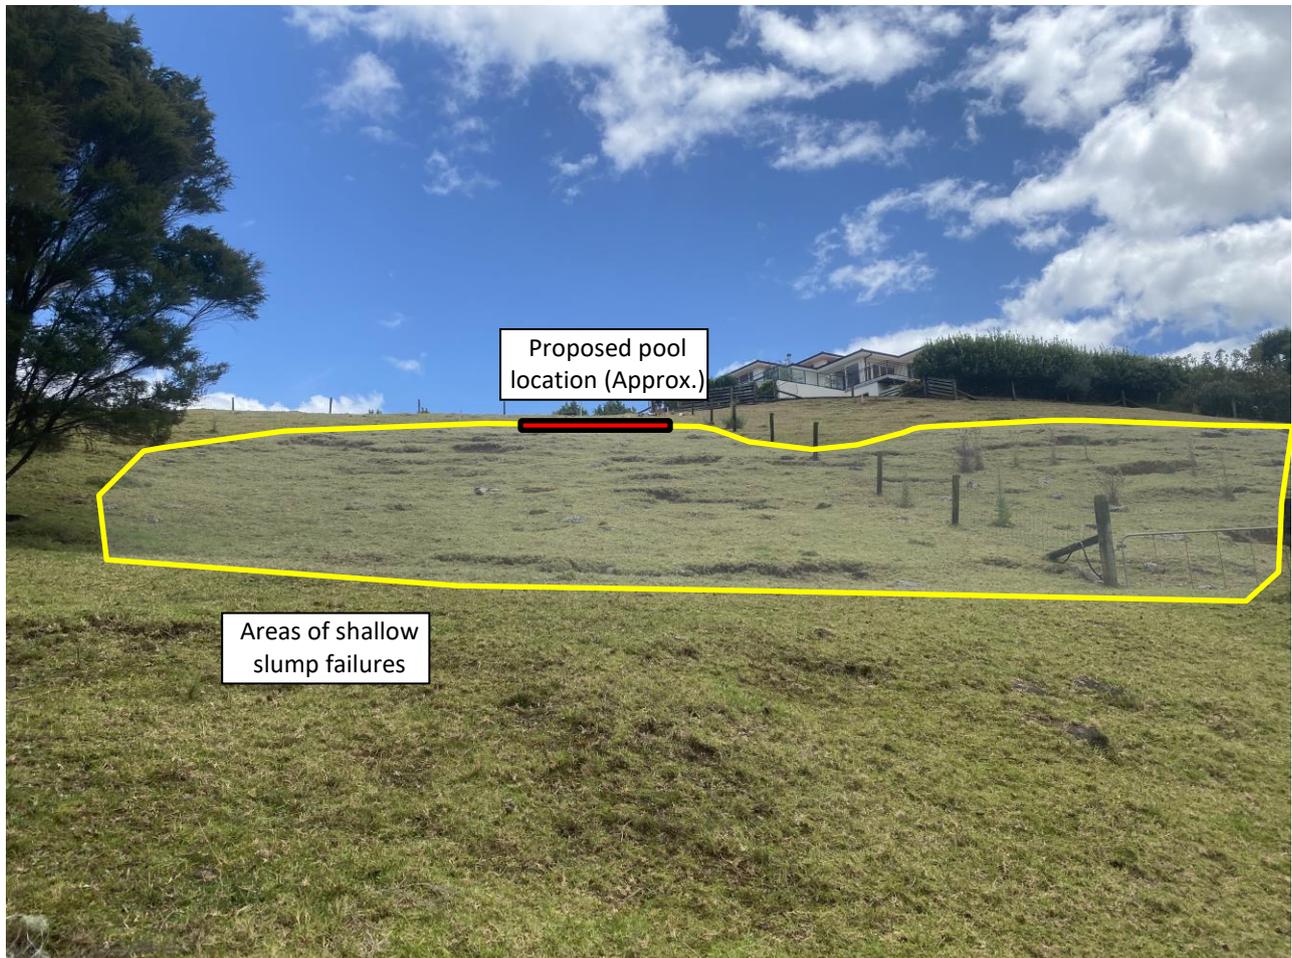
**Figure 3: Instability Features**

Signs of slope instability observed within the vicinity of the site are typical for creep behaviour, with irregular ground surfaces observed across large areas of moderate slopes with no obvious escarpment. The area immediately below the proposed pool location is more evident of this, with small, shallow-seated slump failures and terracette formations. Refer Figure 3 below. This area is also shown to have a light concave nature

compared to the surrounding topography – refer Figure 4. No signs of deep-seated instability features were observed within the vicinity of the investigated area.

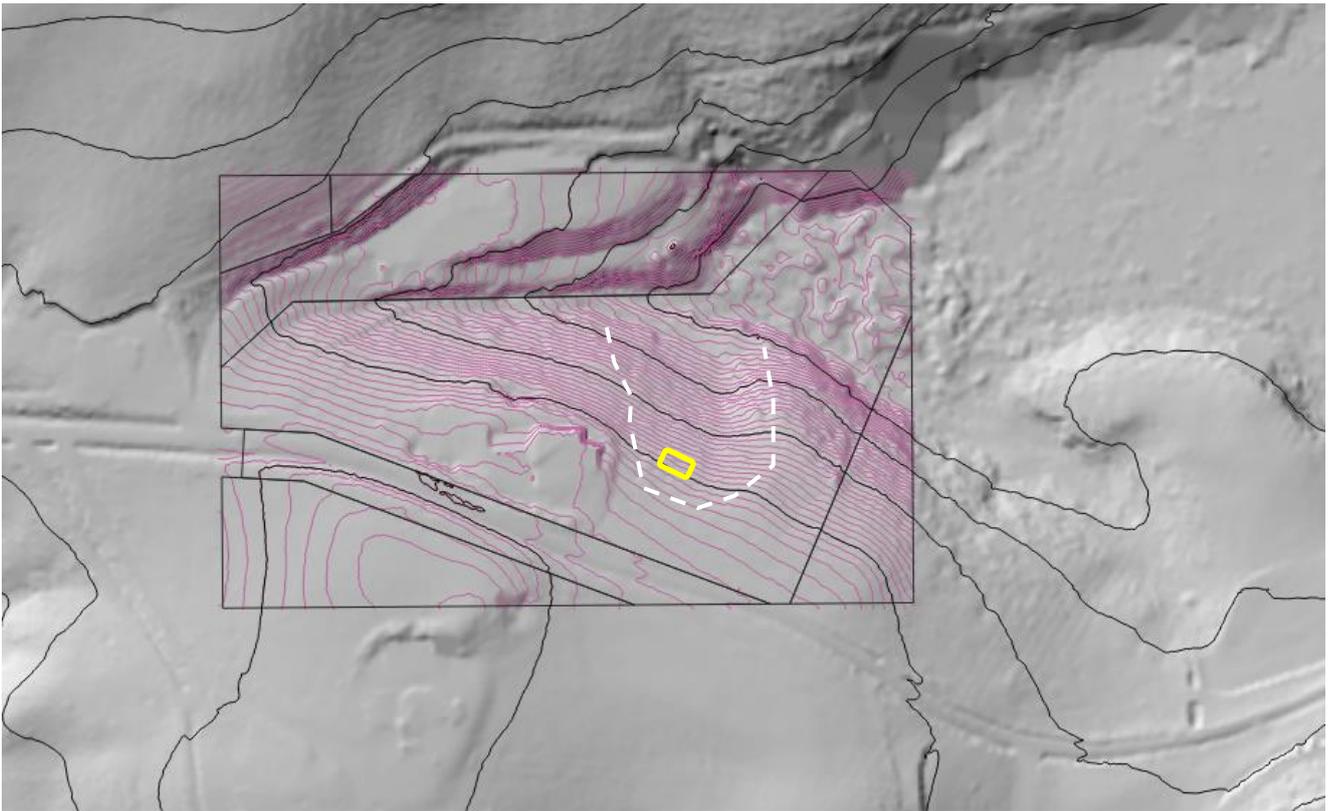
Figure 4: Site Features (LIDAR DEM & 0.5m Contours)

The slopes immediately below the proposed pool & eastern half of the existing dwelling average approximately 20°. The subject area has also likely undergone toe erosion in extreme weather events / coastal flooding events due to the nearby water courses. The overall site contour across and below the proposed pool location shows a slight concave feature which will concentrate stormwater flows from the above catchment. Due to the above reasons, this area of the site shows more obvious signs of shallow instability. The steeper portion of the site, located within the regenerated bush-clad slopes at the eastern extent of the site, averages approximately 24°.

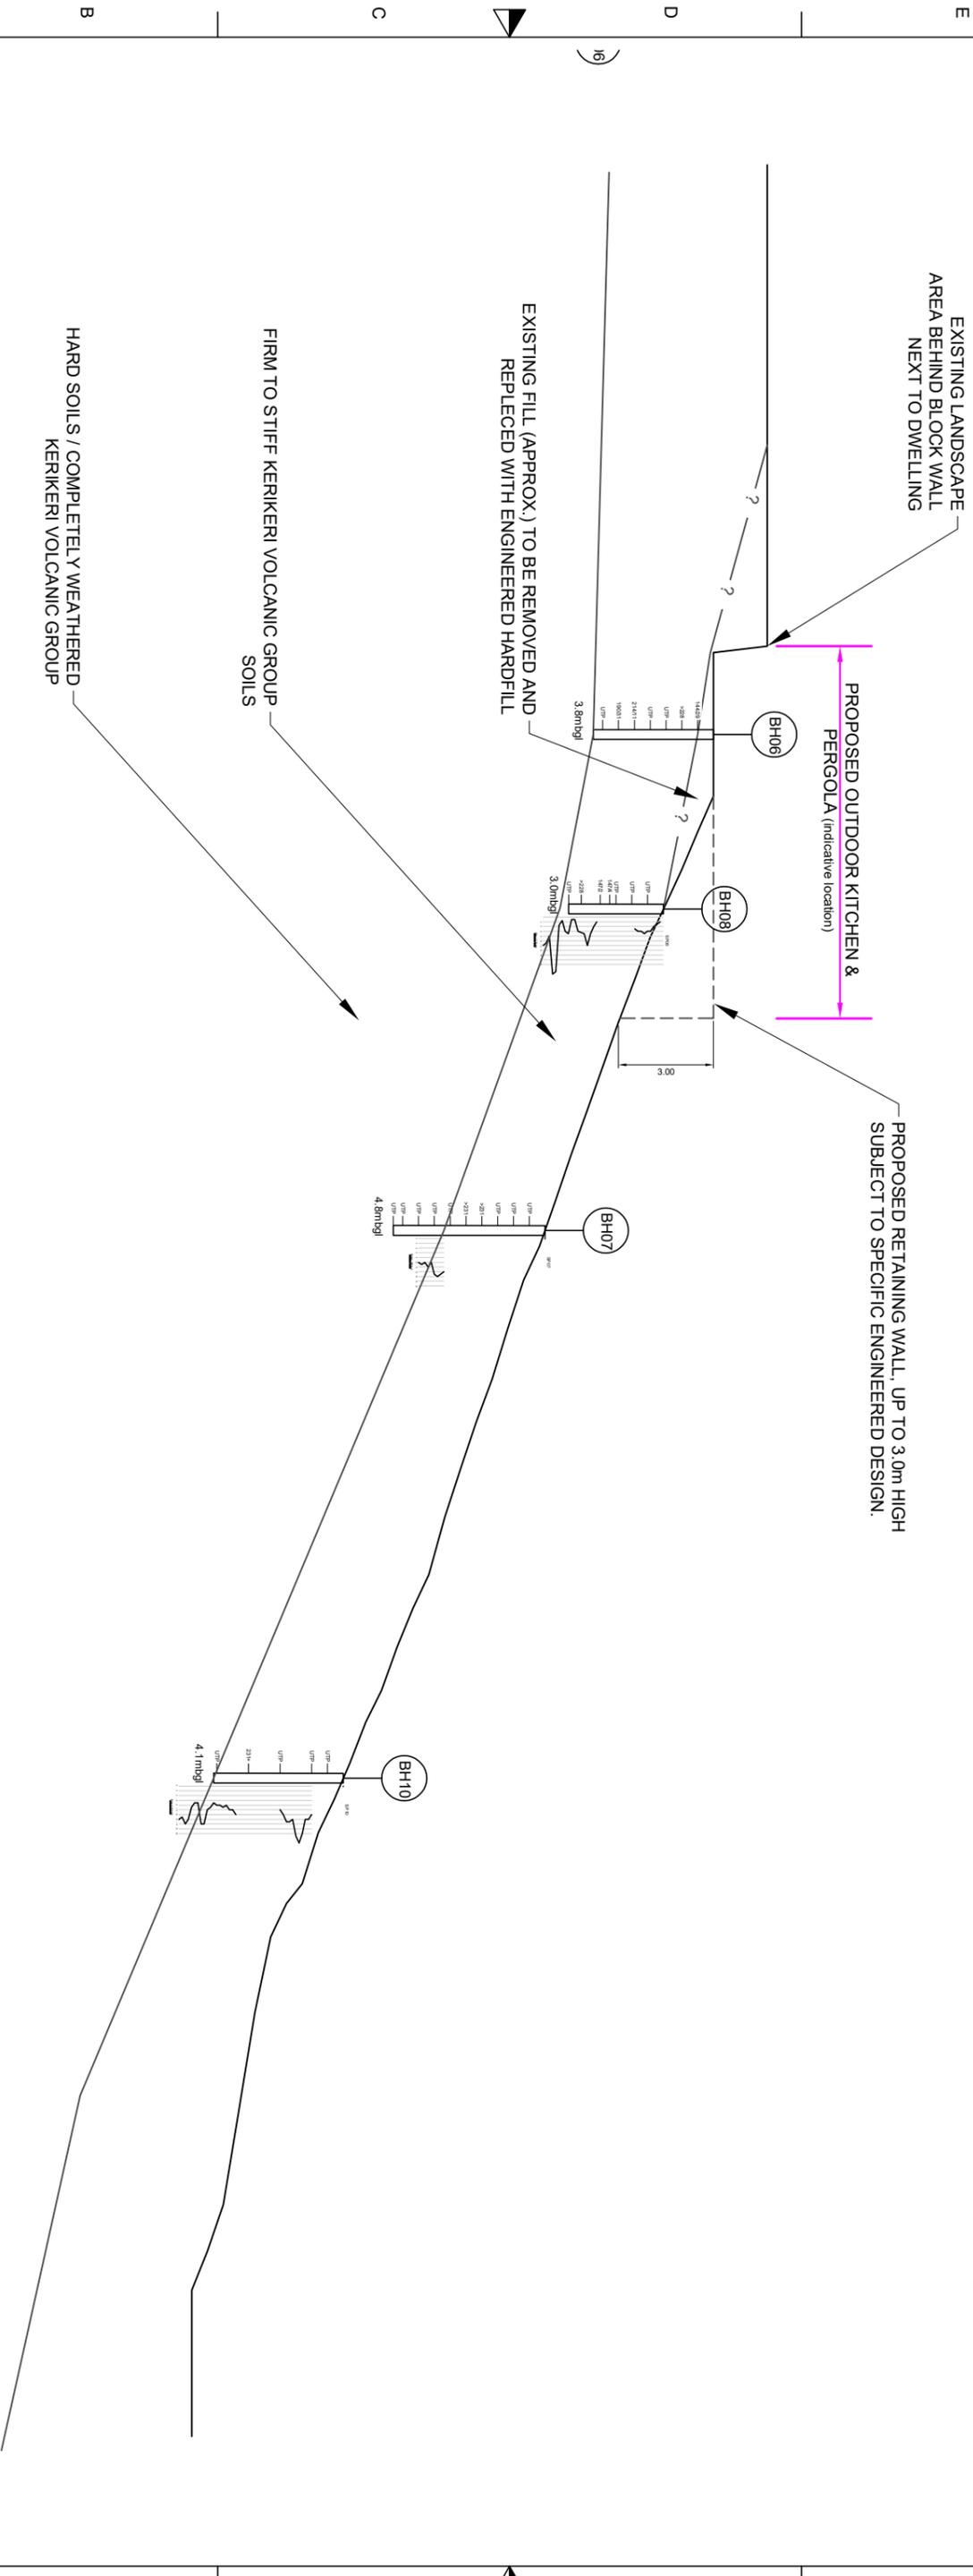
DWG		Geological Cross Section A-A'	
Scale	1:200 @A3	Checked	WT
Drawn	CN	Approved	WT
Date	March 2025	File	T:\CLIENTS\IAN AND VICKI SMITH\05 023 56 KINGFISHER DRIVE\ENGINEERING\GEO\GEO\DRAWINGS\GEO\TECH DRAWINGS.DWG

- NOTES:**
1. THIS DRAWING IS BASED ON MEASUREMENTS BY TAPE AND CLINOMETER AND IS APPROXIMATE ONLY.
  2. THE GROUND MODEL HAS BEEN INFERRED FROM THE DATA OBTAINED ON SITE. INFERENCES ABOUT THE CONDITIONS BETWEEN TEST LOCATIONS HAVE BEEN MADE BUT CANNOT BE GUARANTEED.
  3. DRAWING NOT TO BE USED FOR CONSTRUCTION PURPOSES.

Geotechnical design parameters recommended in this report are based on in-situ test results, empirical relationships, and observations of nearby slopes. Refer Table 3 below for soil parameters adopted within this report. Depths for the units are shown in Table 2 and on the appended drawings (Appendix A).

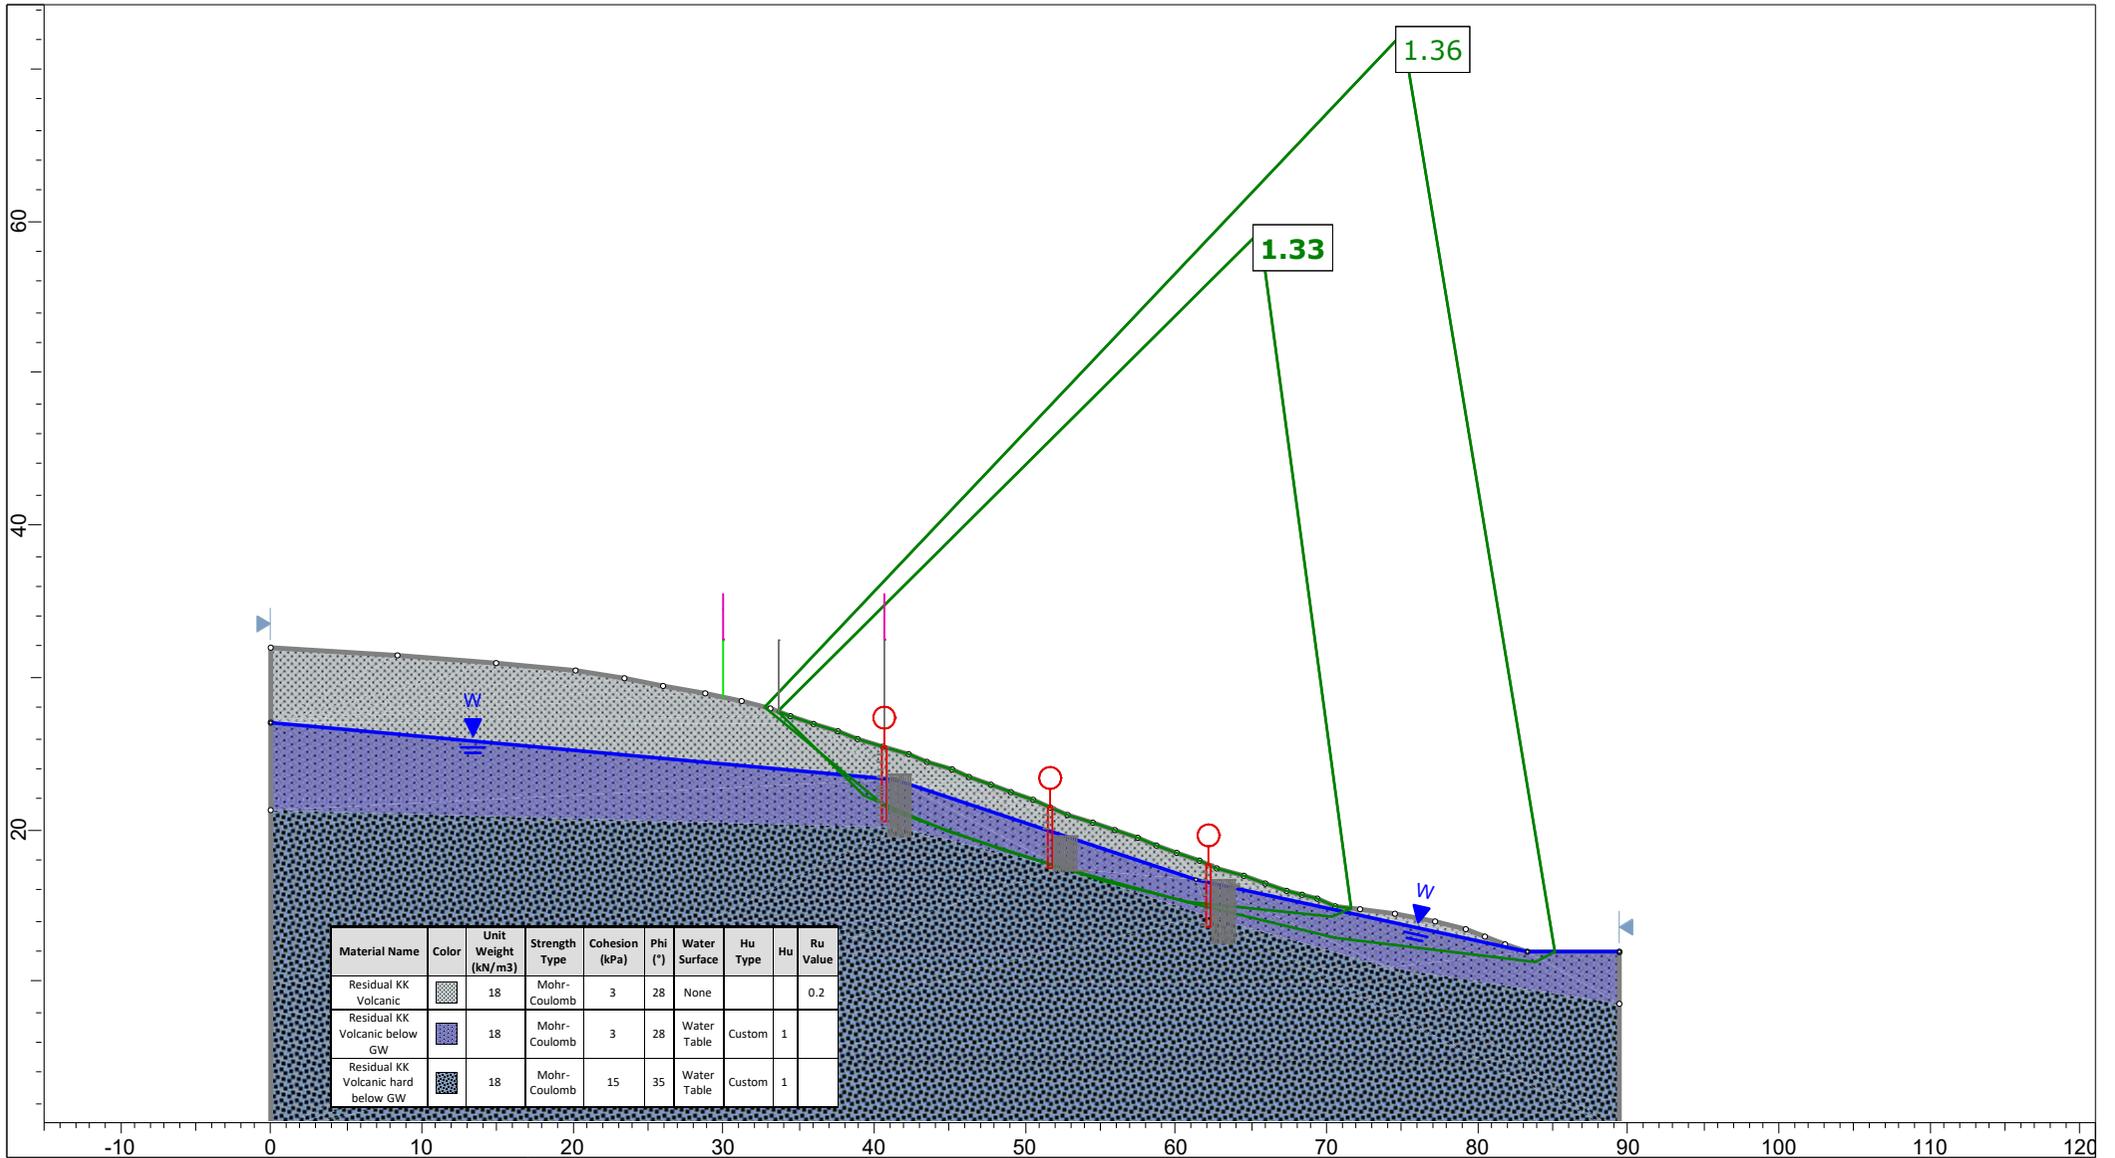
Project	25 023 stability analysis		
Group	Cross Section A-A'	Scenario	A-A' elevated pre development
Drawn By	CN	Scale	1:500
Date	12/03/2025 8:18:13 AM	File Name	A-A' elevated pre development

Material Name	Color	Unit Weight (kN/m3)	Strength Type	Cohesion (kPa)	Phi (°)	Water Surface	Hu Type	Hu	Ru Value
Residual KK Volcanic		18	Mohr-Coulomb	3	28	None			0.2
Residual KK Volcanic below GW		18	Mohr-Coulomb	3	28	Water Table	Custom	1	
Residual KK Volcanic hard below GW		18	Mohr-Coulomb	15	35	Water Table	Custom	1

Section I.D.	Scenario	Result at development	Required	Outcome	Notes
A-A'	Existing site conditions - elevated	1.3	-	-	<ul style="list-style-type: none"> <li>As expected for 20° slopes. However, site subject to shallow soil creep.</li> </ul>
	Proposed pool - Elevated groundwater	1.2	1.3	NOT OK	<ul style="list-style-type: none"> <li>Minimum FOS = 1.21 within proposed fill below pool, and 1.22 across pool.</li> <li>Remedial measures required. Failure surfaces approximately 4.5m deep which would need to be retained.</li> <li>Remedial measures may include:               <ul style="list-style-type: none"> <li>In-ground retaining wall and retaining of fill below the pool.</li> <li>Lowering the elevation of the pool and no filling down-slope of the pool (some retaining will still be required to mitigate shallow soil creep on downslope side of pool). This option is cheapest and has been included below:</li> </ul> </li> </ul>

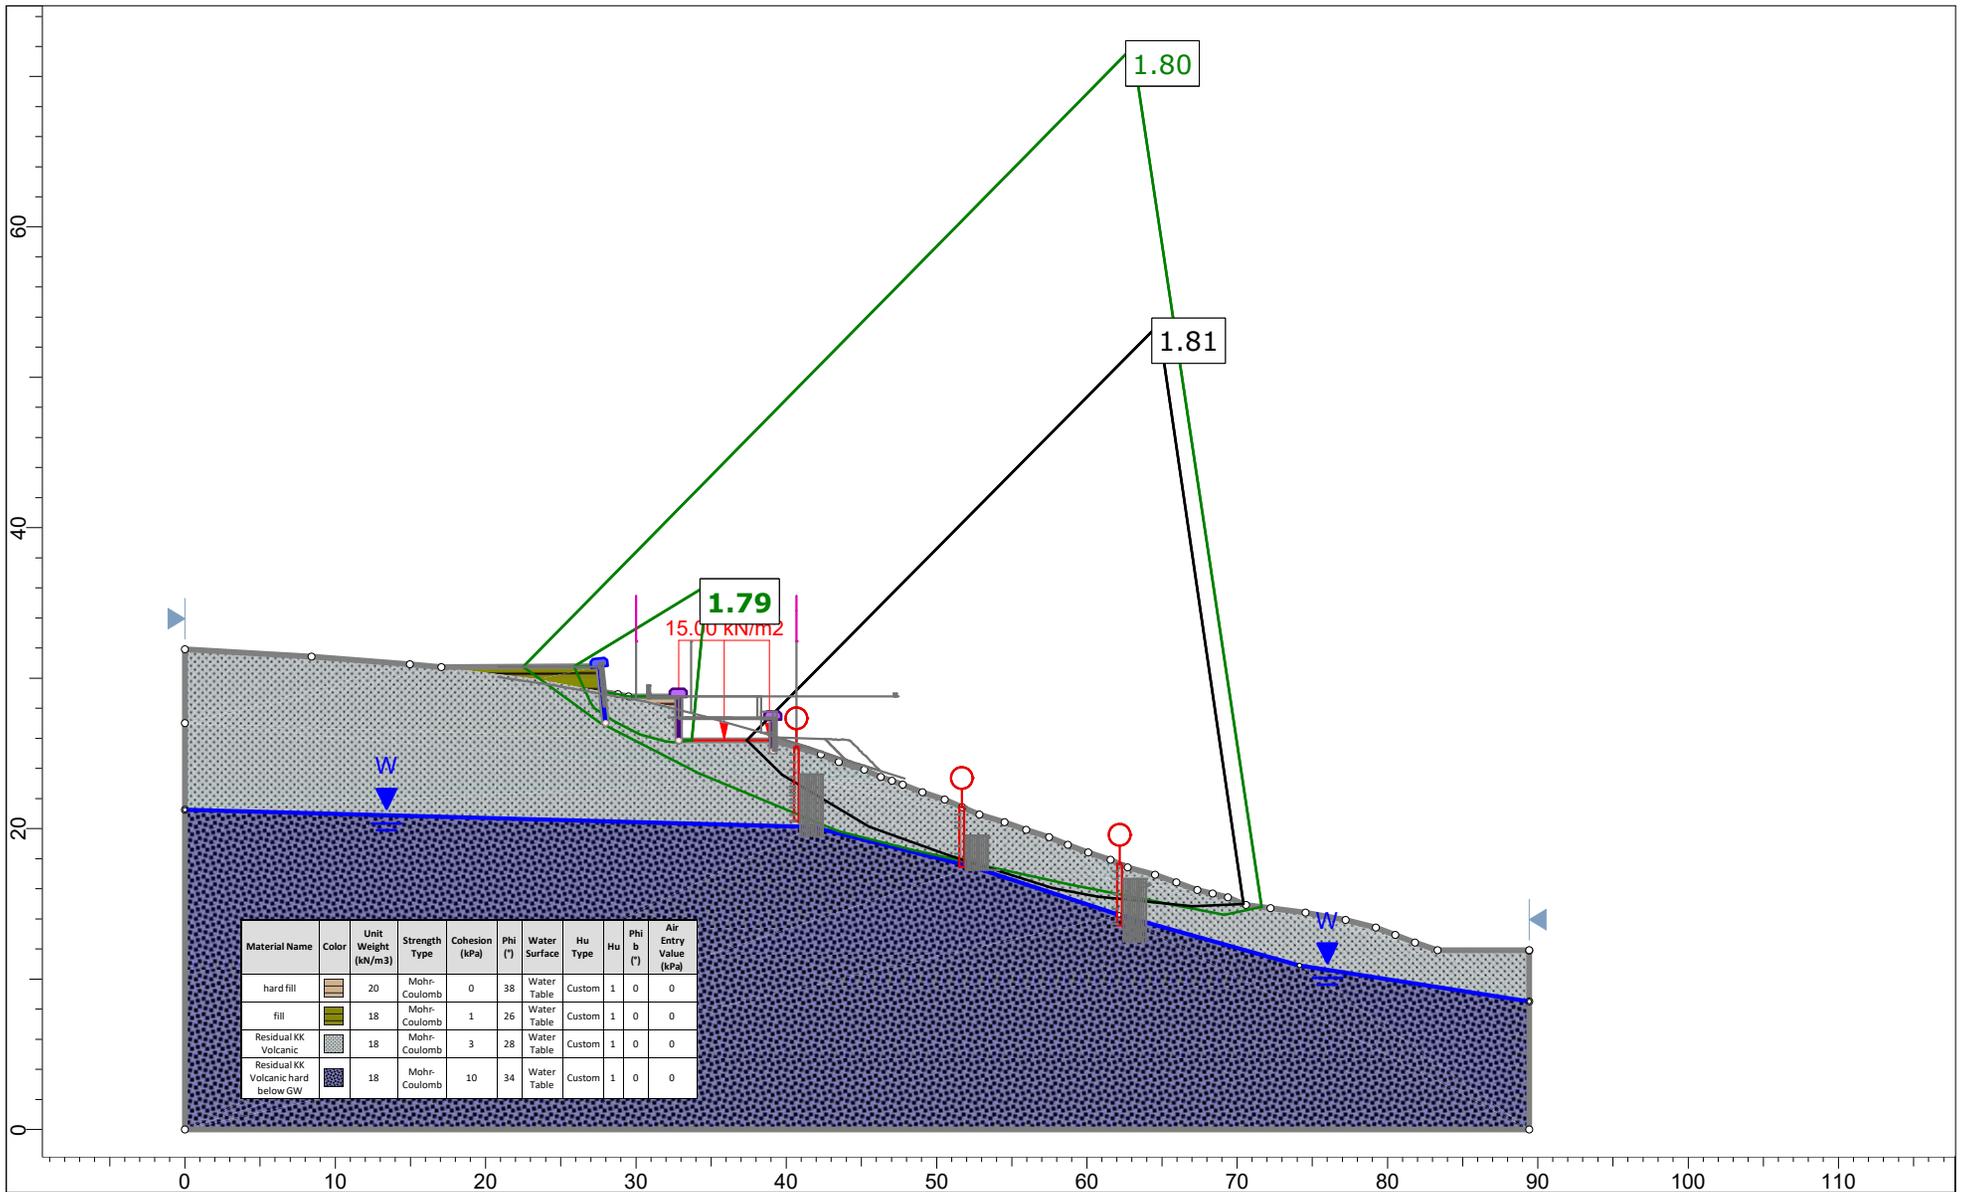
Project	25 023 stability analysis		
Group	Cross Section A-A'	Scenario	A-A' normal GW post dev lowered pool 1.4m
Drawn By	CN	Scale	1:500
Date	12/03/2025 3:39:39 PM	File Name	A-A' normal GW post dev

Material Name	Color	Unit Weight (kN/m <sup>3</sup> )	Strength Type	Cohesion (kPa)	Phi (°)	Water Surface	Hu Type	Hu	Phi b (°)	Air Entry Value (kPa)
hard fill		20	Mohr-Coulomb	0	38	Water Table	Custom	1	0	0
fill		18	Mohr-Coulomb	1	26	Water Table	Custom	1	0	0
Residual KK Volcanic		18	Mohr-Coulomb	3	28	Water Table	Custom	1	0	0
Residual KK Volcanic hard below GW		18	Mohr-Coulomb	10	34	Water Table	Custom	1	0	0
