Project Number 28842.000.001

Preliminary and Detailed Site Investigation

Mt Pokaka Sawmill, Kerikeri, Northland

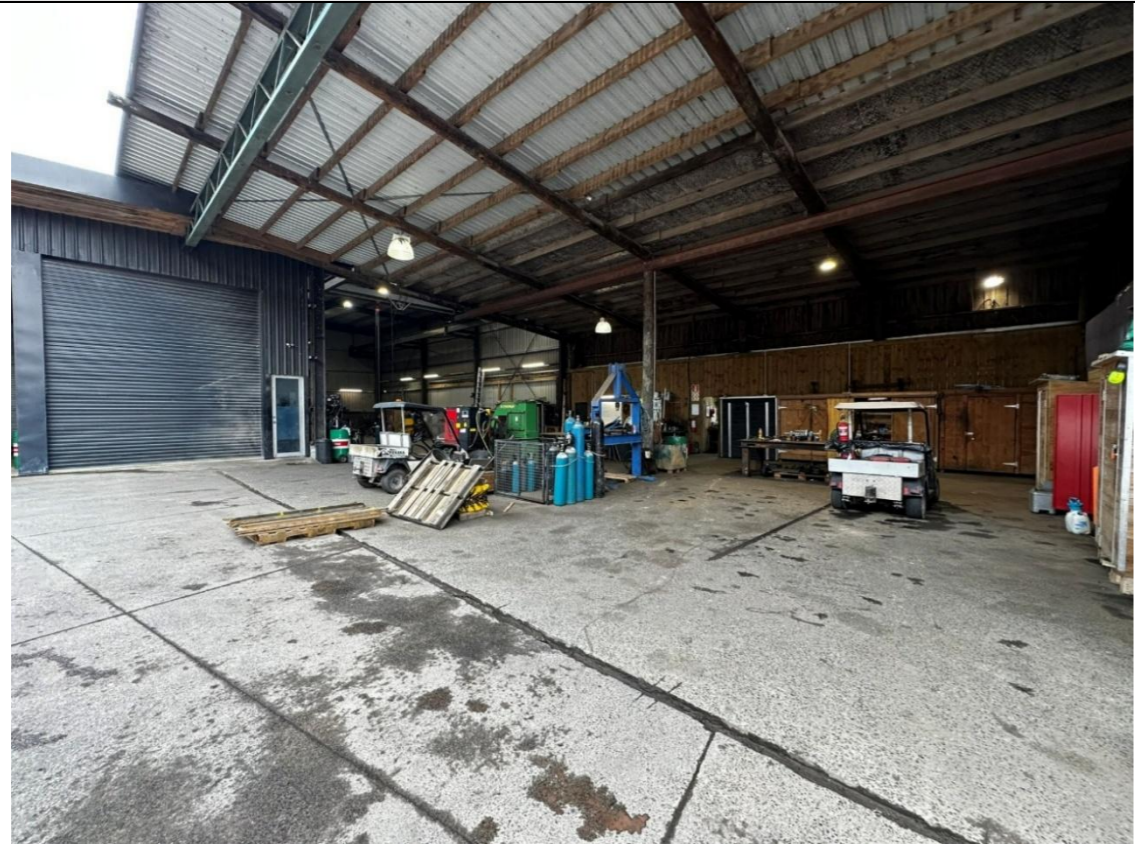
The engineering workshop is used for maintenance of site vehicles and machinery, as well as storage of chemicals required for maintenance and operations (e.g. lubricants, oils, etc.). Chemicals are primarily stored in containers up to 200 L (as supplied by manufacturer) on wooden pallets, shelves, and bunded trolleys. The workshop floor is concrete, with occasional isolated staining observed. Grates around the edge of the slab appear clear of debris.

Photo 1: Minor staining visible in the middle section of the engineering workshop.

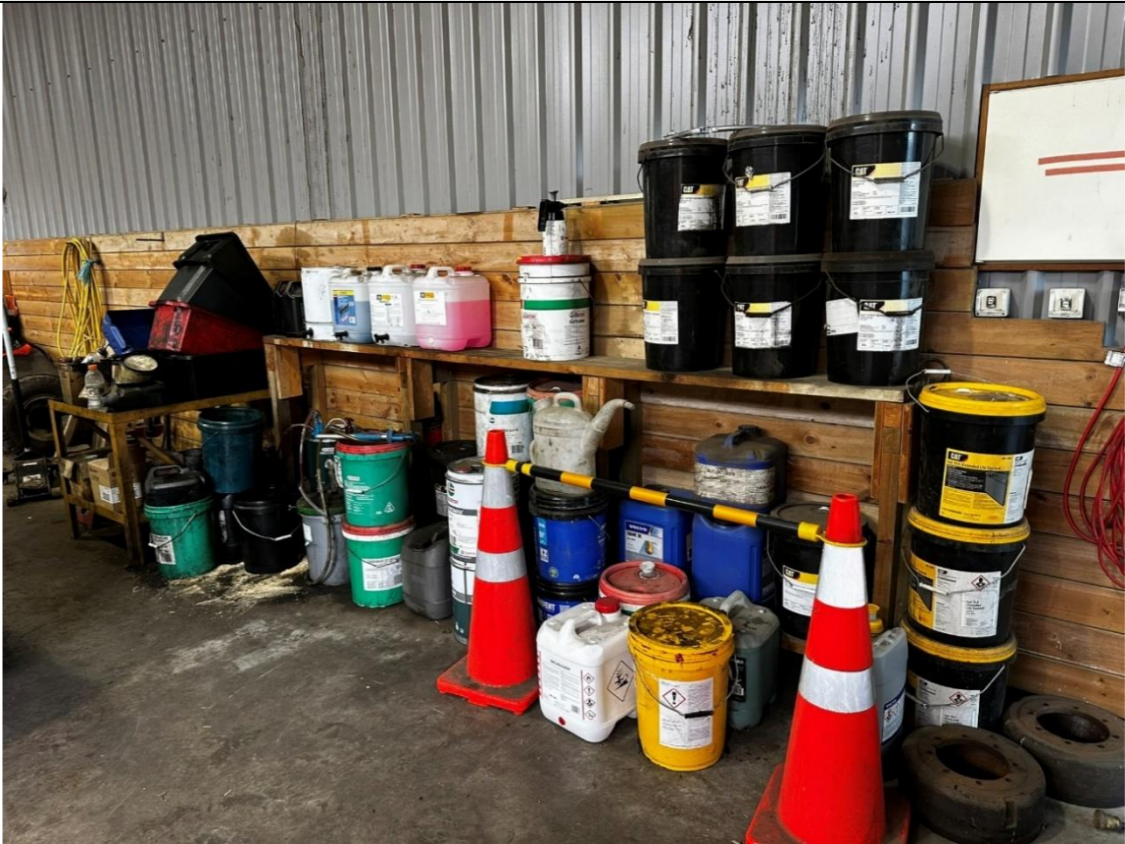
Photo 2: Various chemicals used for maintenance and operations stored in the engineering workshop.

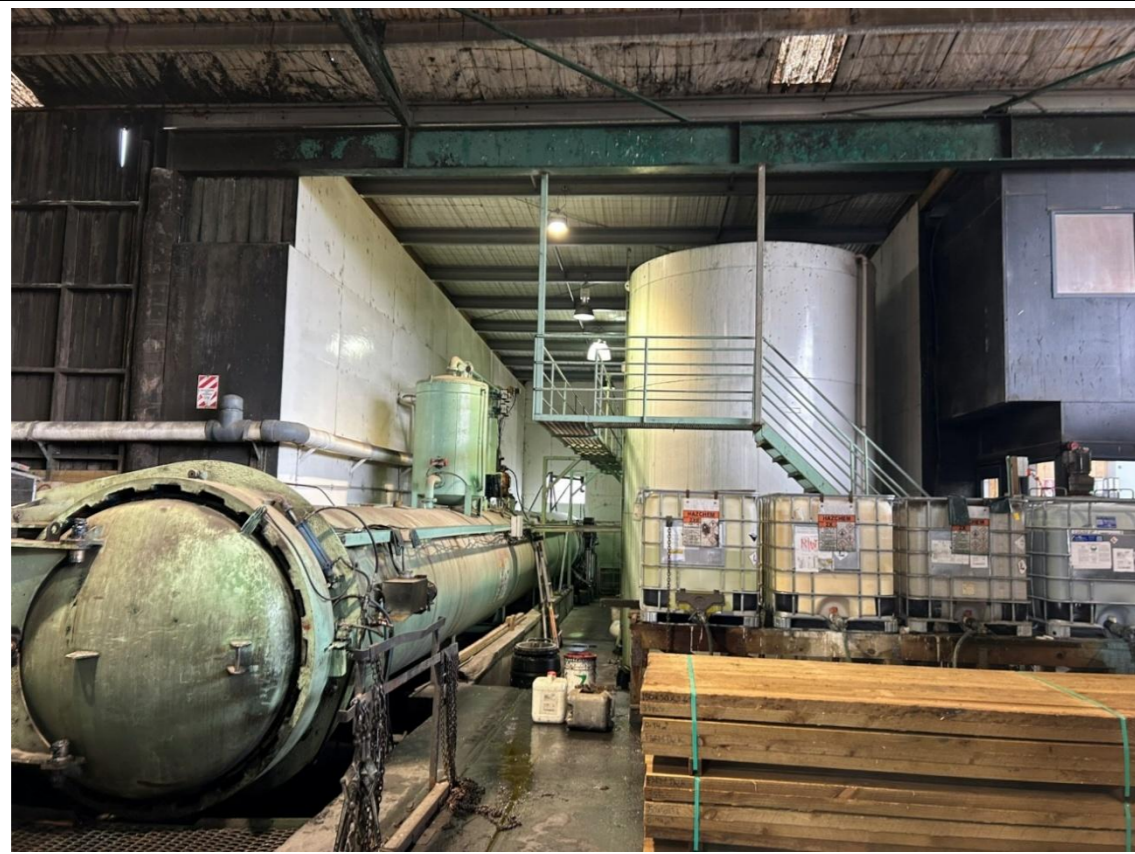
The main treatment plant building is used for treatment of timber to various timber treatment levels (i.e., H3, H4, and H5) using Micronized Copper Azole (MCA) or Chromated Copper Arsenate (CCA). The chemicals are delivered by tanker and pumped into a 20,000 litre (L) concentrate tank. The concentrate is dosed into working tanks and diluted prior to use in the treatment cylinder. The newly treated timber is placed on the drip pad to dry. The surface of the drip pad was observed to be stained green as a result of treatment chemicals dripping off the drying timber. ENGEO was informed that the treatment plant is bunded to comply with Health and Safety at Work (Hazardous Substances) Regulations 2017 (LI 2017/131) *Clause 17.100 Secondary containment for above ground stationary containers*, and any spills or leaks of treatment chemicals are captured in the drains surrounding the treatment plant and reused. No staining or spills were observed on the ground surface outside of the bunded area / drains. Some MCA treated timber is taken to the sawdust powered kiln building where it is re-dried. Condensate from this process is collected in drains before being transported to the condensate pond and discharge field. A large volume of steam with a strong odour was observed to be produced from this process.

Photo 3: The treatment area within the main timber treatment plant consisting of the treatment cylinder, chemicals stored in IBCs and the mixing tank.

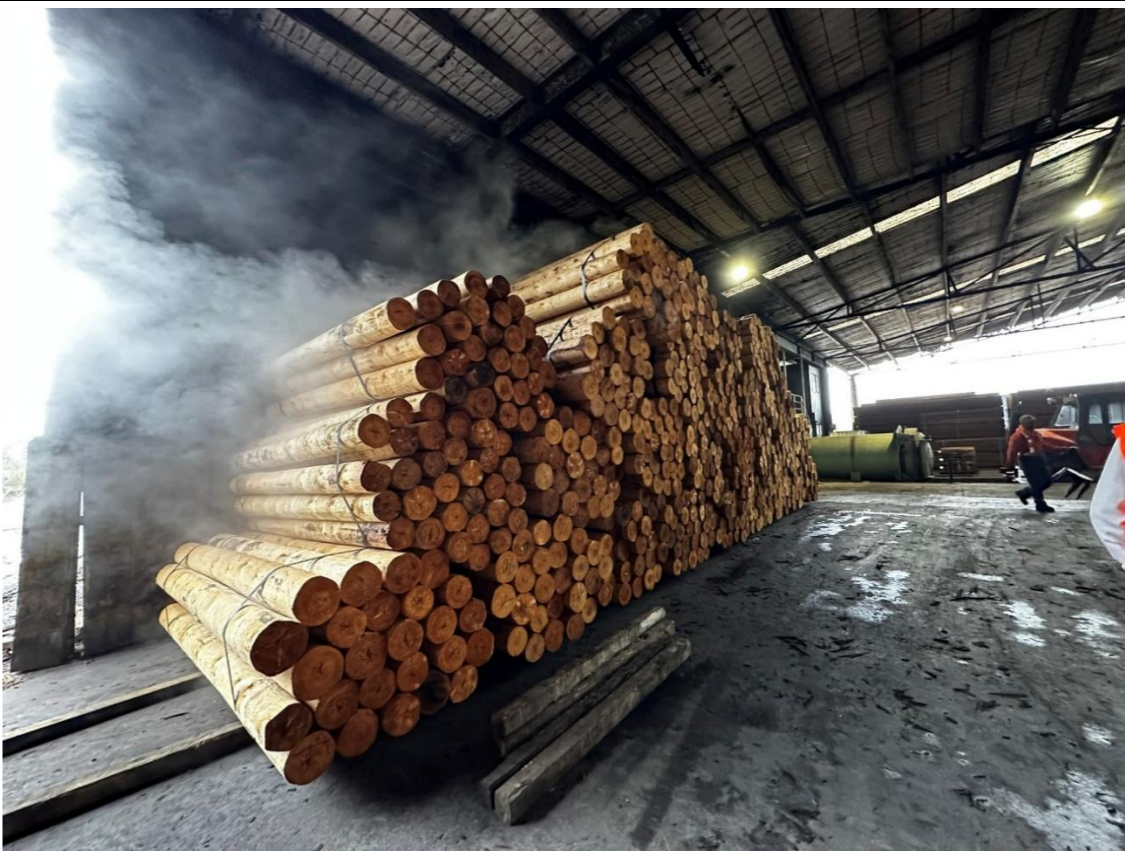
Photo 4: Freshly treated logs on the drip pad.

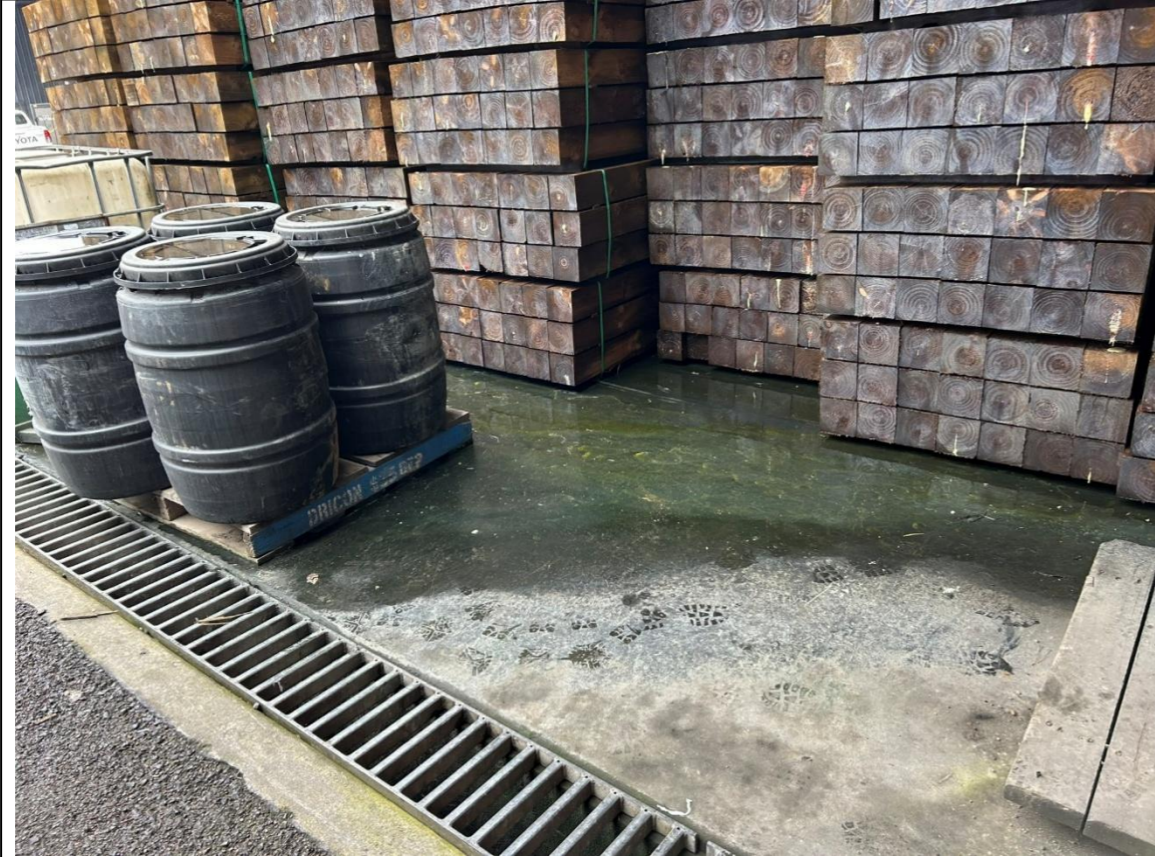
Photo 5: Green chemicals and staining observed on the drip pad.

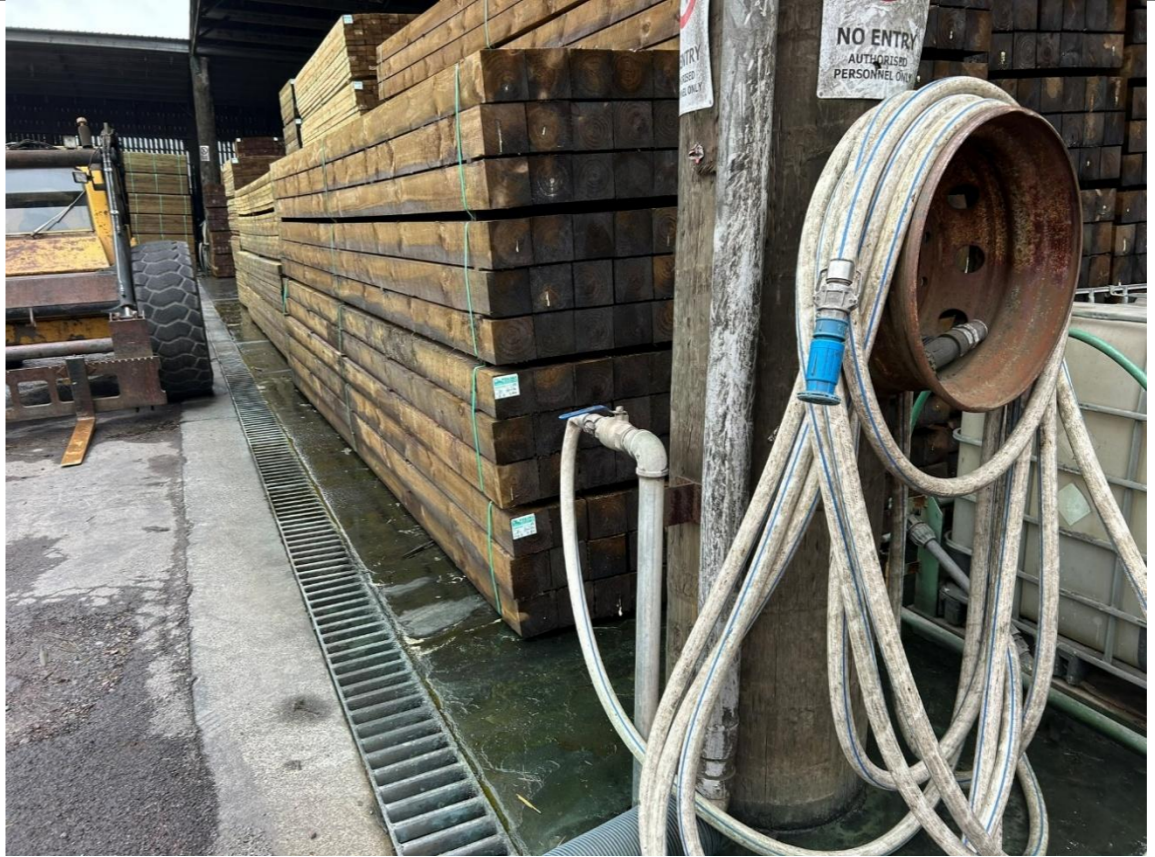
Photo 6: View of the bund capturing chemical runoff from the drip pad preventing staining beyond the drip pad.

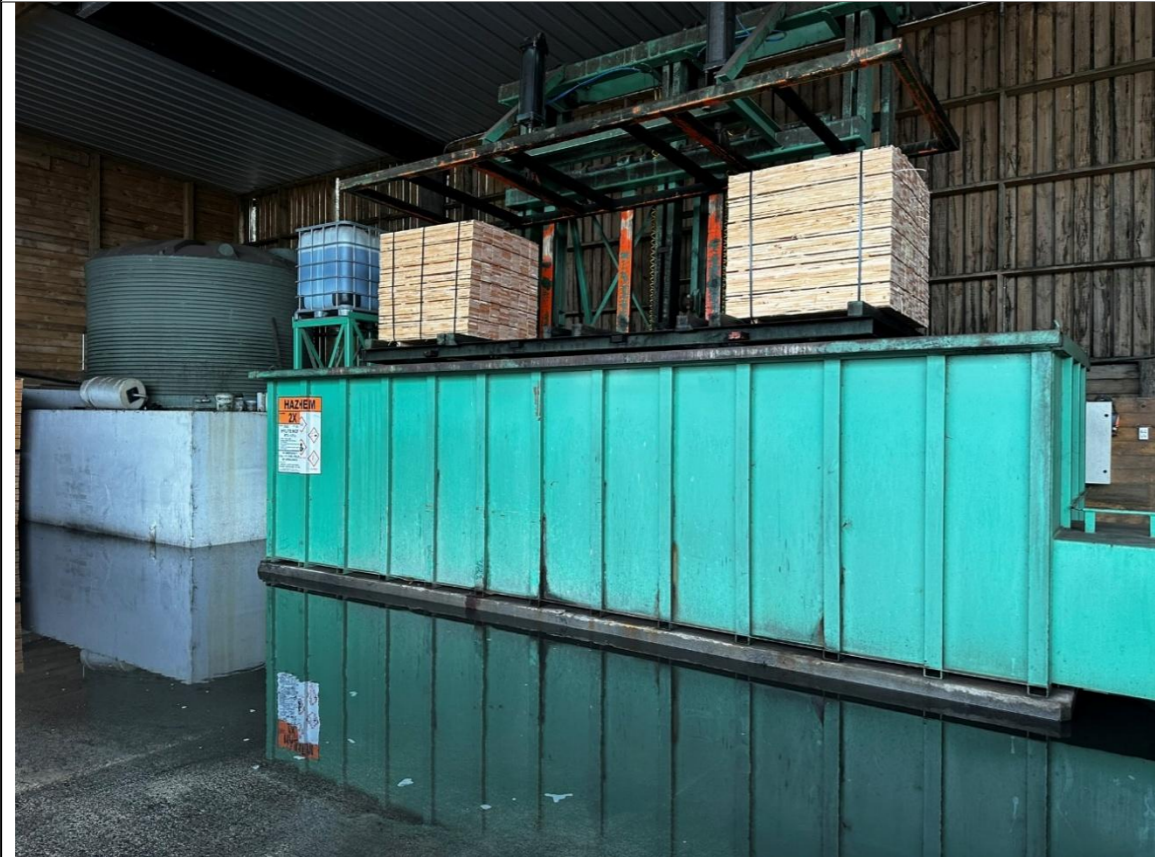
Some timber products are treated with Hylite NCF (anti fungi / mould treatment) in a 30,000 L dip tank in the anti-sap treatment area located to the northeast of the main treatment plant. Hylite NCF is stored as a concentrate in an IBC above the dip tank. Treated timber from the anti-sap stain tank is stored near the Reman plant building.

Photo 7: The dip tank where anti-sap treatment with Hylite NCF occurs. Liquid at the surface is rain water, entering due to the slope of the site,

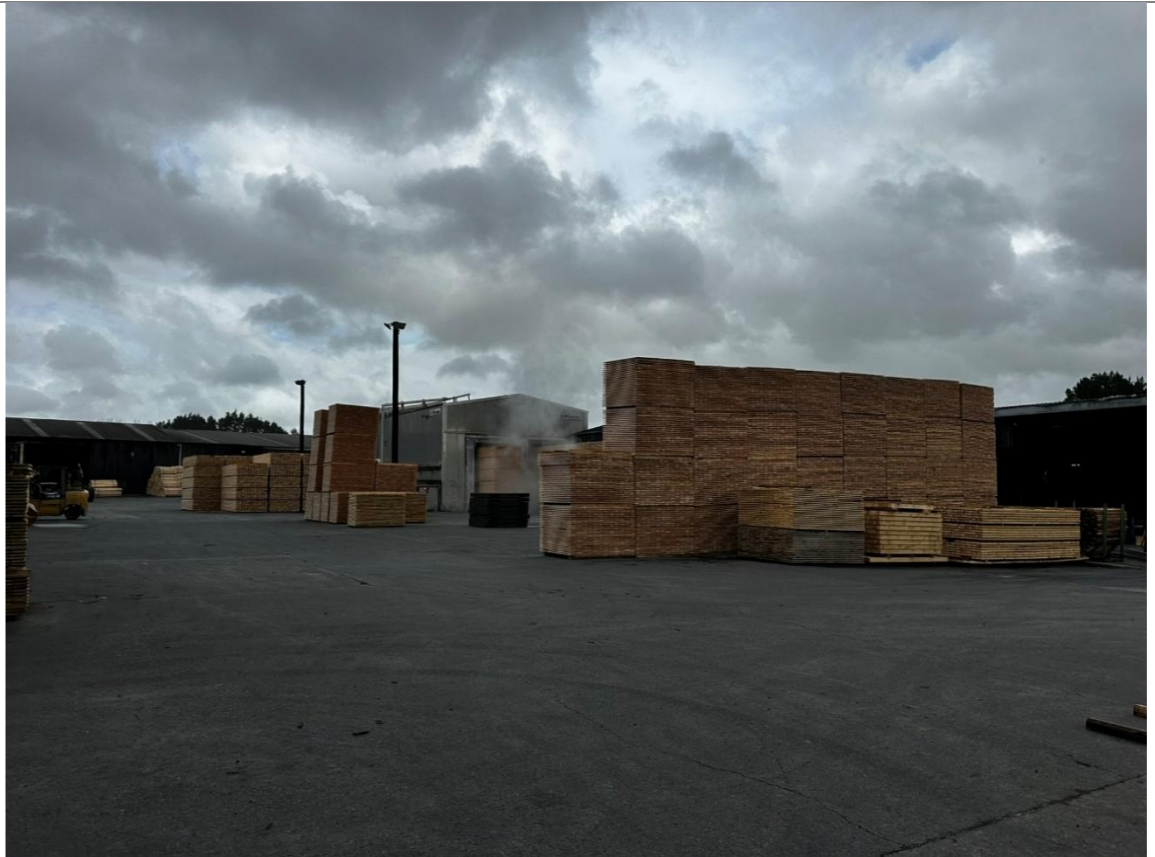
Photo 8: Southeast-facing view of the timber stored around the kiln building where timber is redried. Steam can be seen discharging to the air.

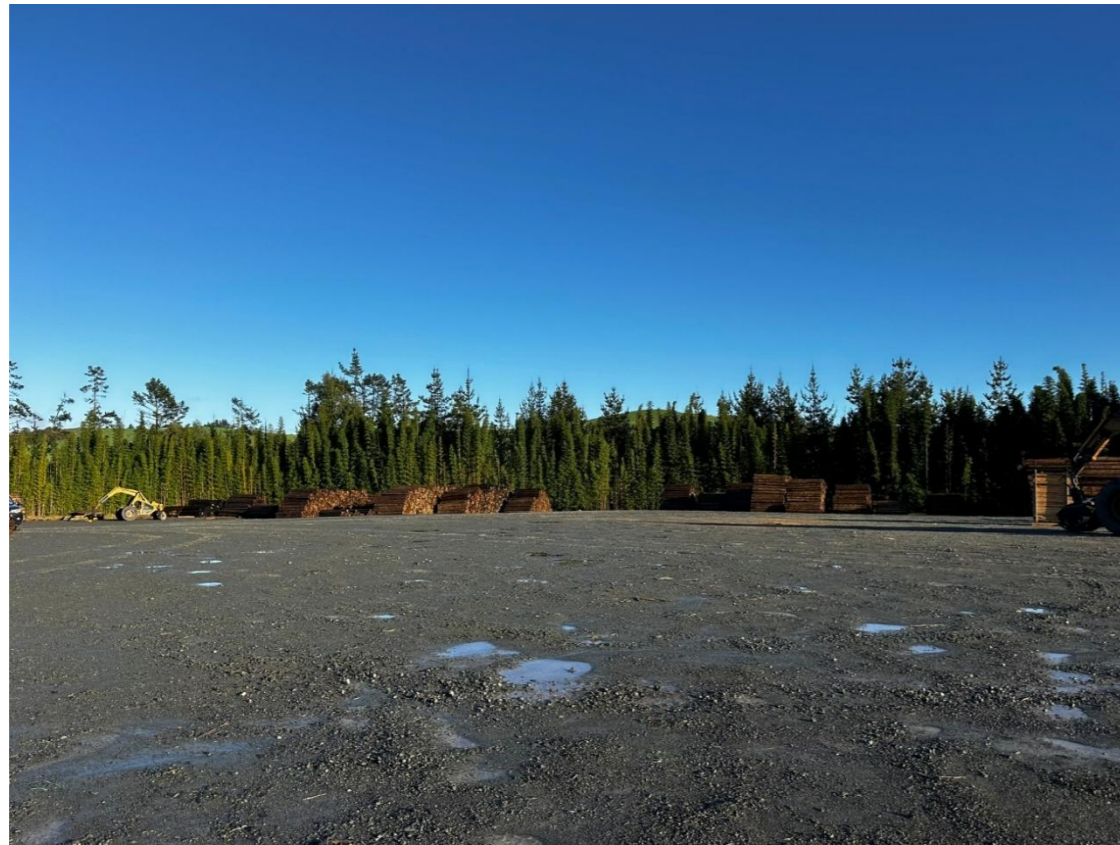
Photo 9: Northwest-facing view of the northern timber storage yard.

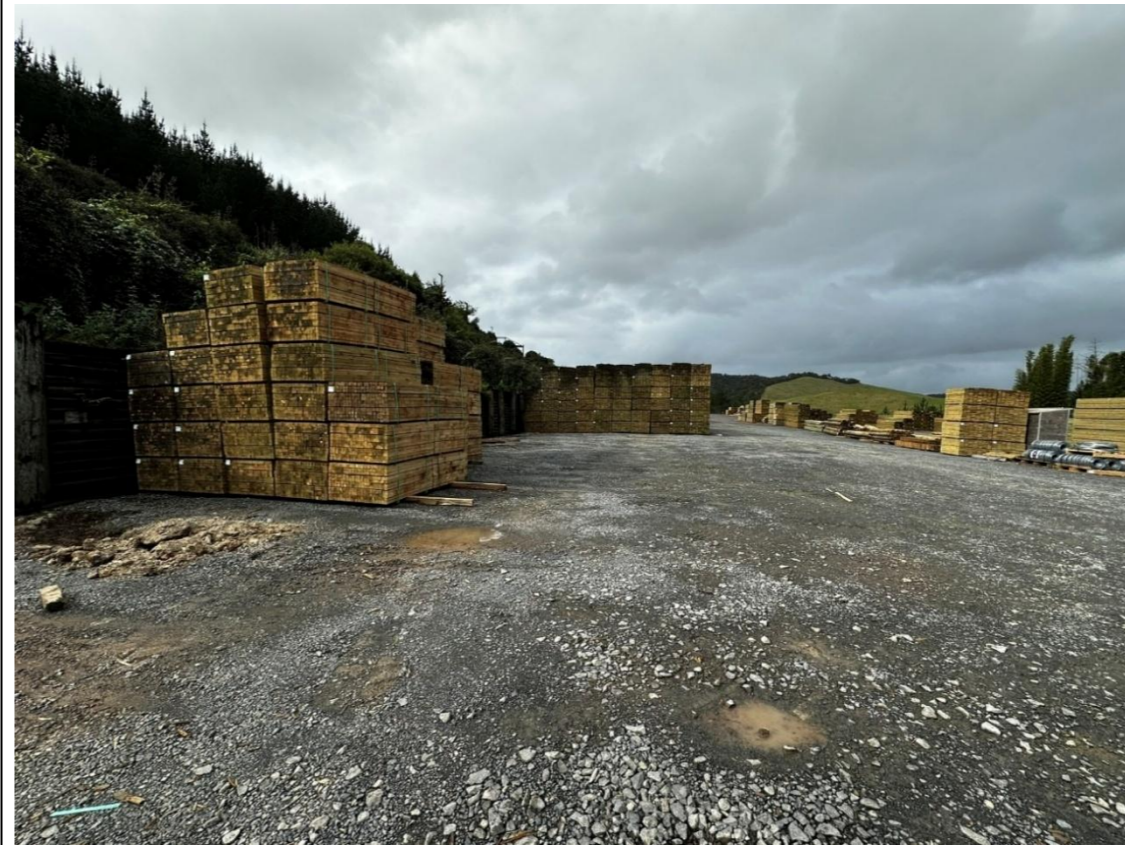
Two timber storage yards are located at the northern and southern ends of the site. Based on information provided by the site representative, the northern yard is predominantly used for storage of H4 and H5 treated timber, while the southern yard is predominantly used for the storage of H3 and H4 treated timber. Timber in the southern yard was stored on timber bearers, providing elevation from the ground surface. No visible staining, spills or leaks were observed on the gravelled surface.

Photo 10: East-facing view of the southern timber storage yard.

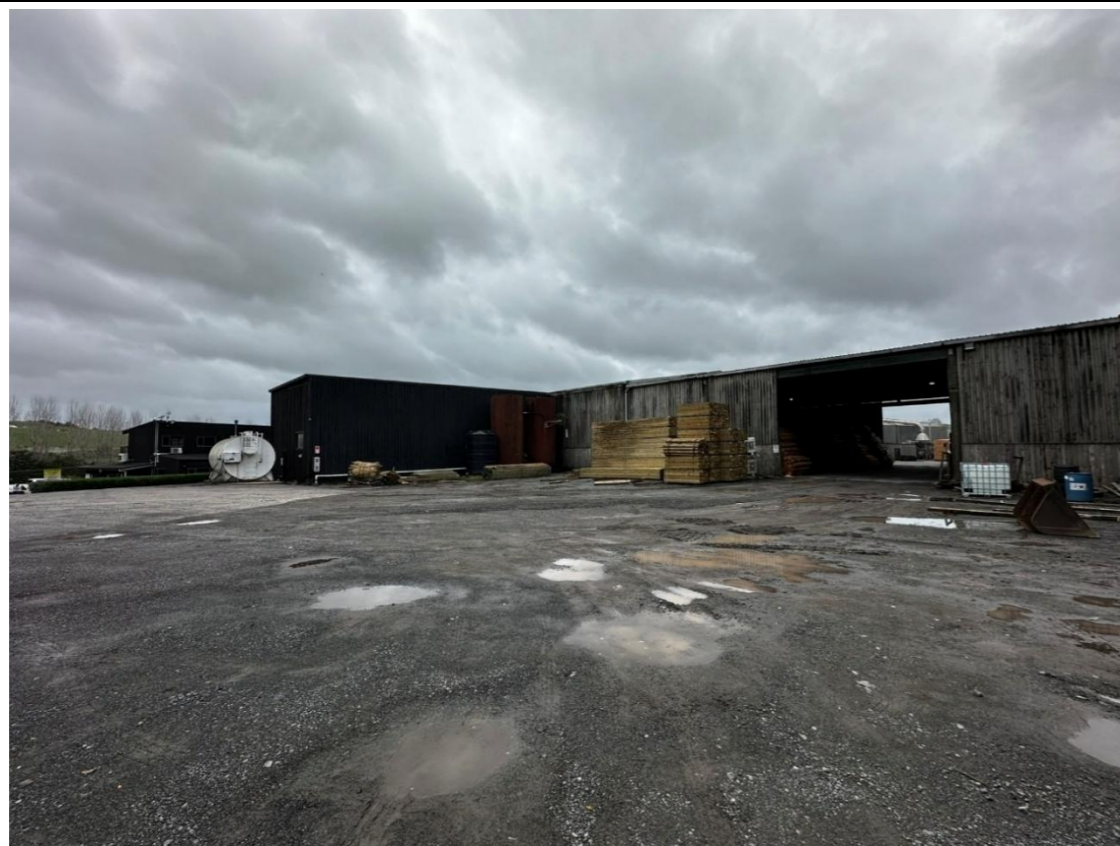
Photo 11: West-facing view of the AST storage yard.

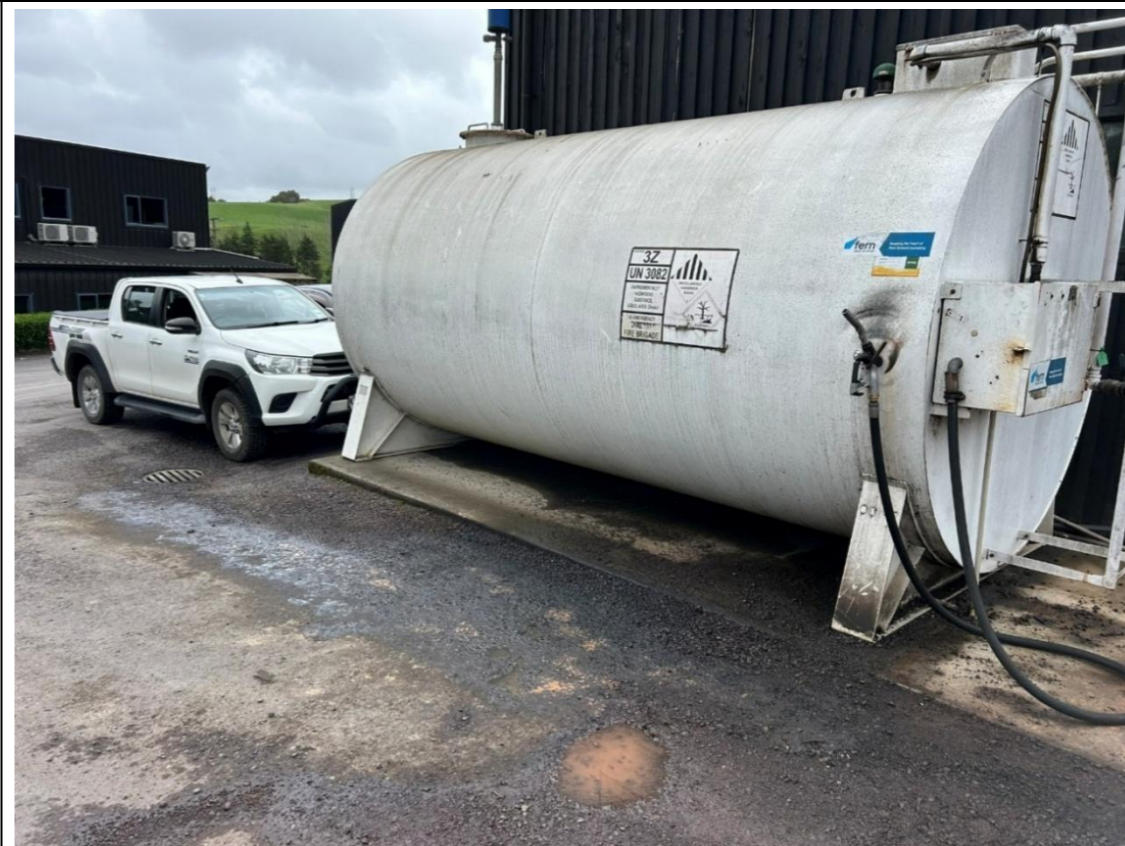
The AST yard is located to the north of the office building. It is mainly used for the storage of treated timber, empty IBC containers and tanks. We were informed by a site employee that the tanks are used for the storage of water. A large 20,000 L diesel tank is present south of water tanks and is located on a concrete pad. It was noted that the refuelling point extended outside the edge of the concrete slab, and diesel staining was observed on the ground leading from the refuelling point to a nearby stormwater manhole.

Photo 12: View of the diesel AST. Spilled diesel is visible flowing towards the stormwater drain.

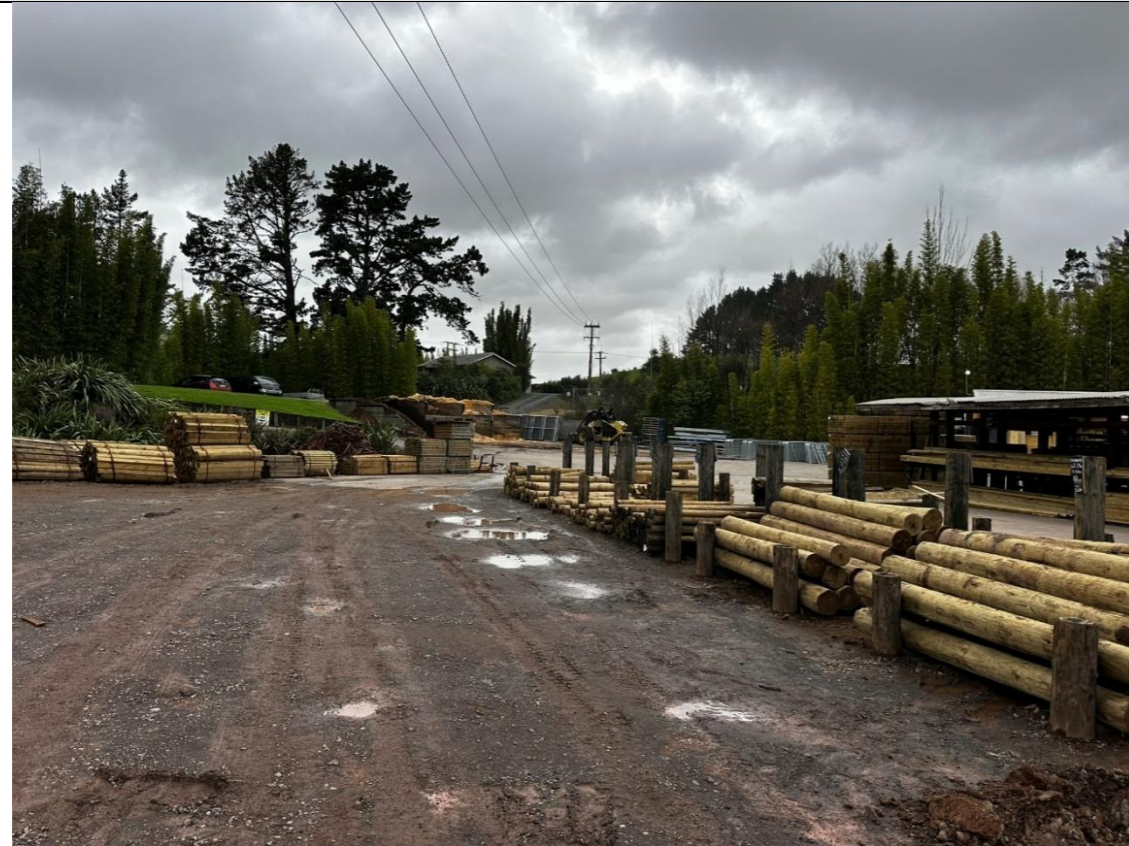
A retail shed is located in the south-eastern corner of the yard. Storage of small volumes of products associated with timber use (glue, varnish, lubricants etc.) were observed within the shed. The shed interior and concrete slab were in good condition, with no visible staining or evidence of leaks observed. Adjacent to the shed, various fencing, packaging, and construction materials (e.g. barbed wire, metal wires, pipes etc.) were wrapped in plastic and stored on the concrete slab.

Photo 13: Southeast-facing view of the retail yard.

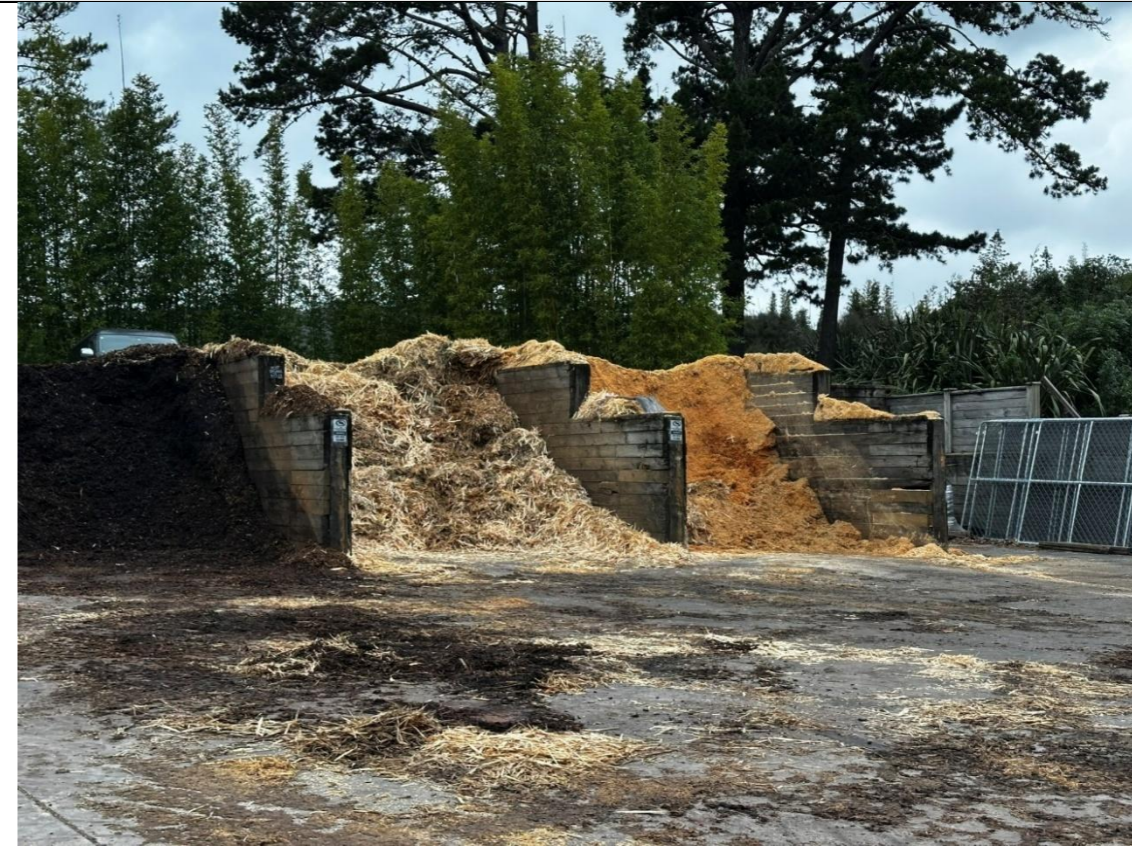
Photo 14: Storage of mulch and sawdust in the southeast of the storage yard.

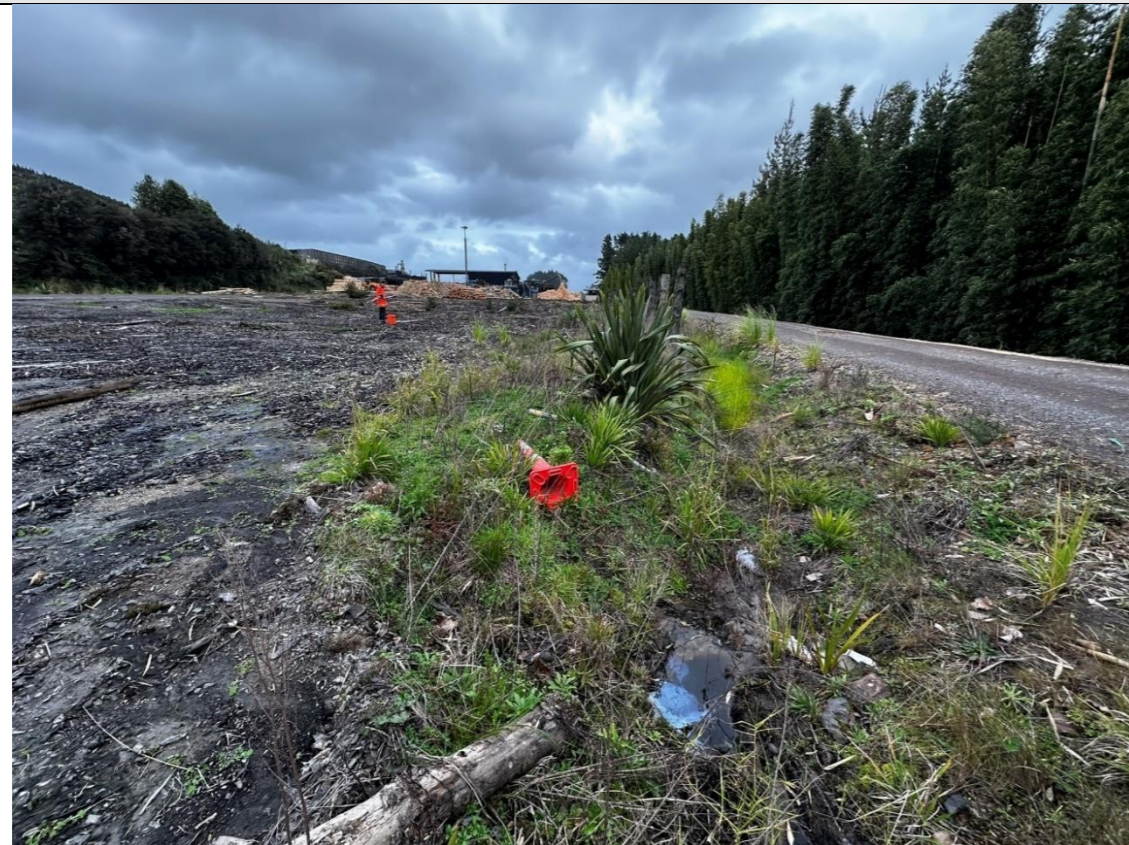
The raw timber storage yard is situated in the north-western portion of the site (north of the sawmill operations) and primarily serves as a storage area for surplus raw timber, offcuts, and sawdust. The ground surface throughout the yard is covered with approximately 300 - 400 mm of mulch. A large stockpile of decomposing sawdust is located in the northern portion of the yard. A narrow channel designed to direct surface water runoff runs along the western boundary of the yard. The water was noted to be murky brown, with an isolated sheen observed on the surface. It is likely that the brown colour may be associated with tannin leaching from bark, whilst the sheen may be indicative of minor hydrocarbon impacts.

Photo 15: South-facing view of the raw timber storage yard. A small channel runs along the western side of the yard with an organic sheen visible on the surface of the water.

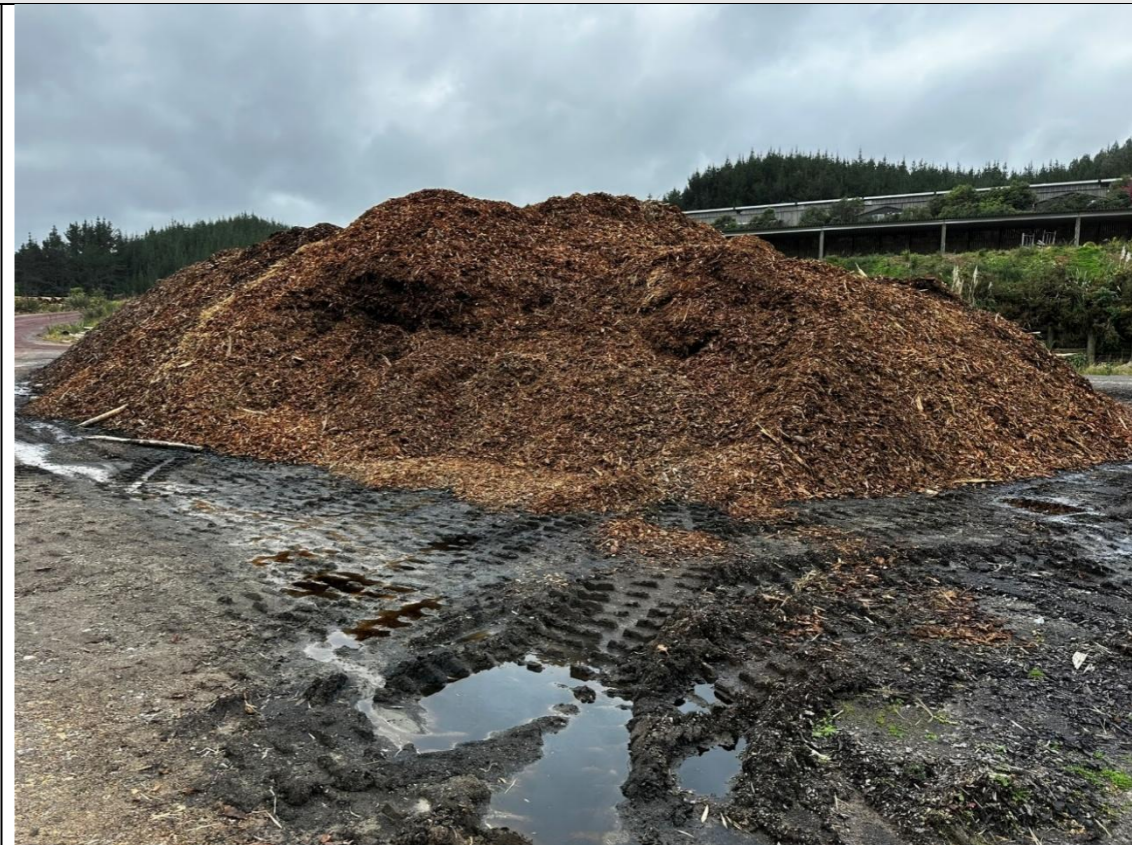
Photo 16: Large stockpile of mulch in the northern portion of the yard.

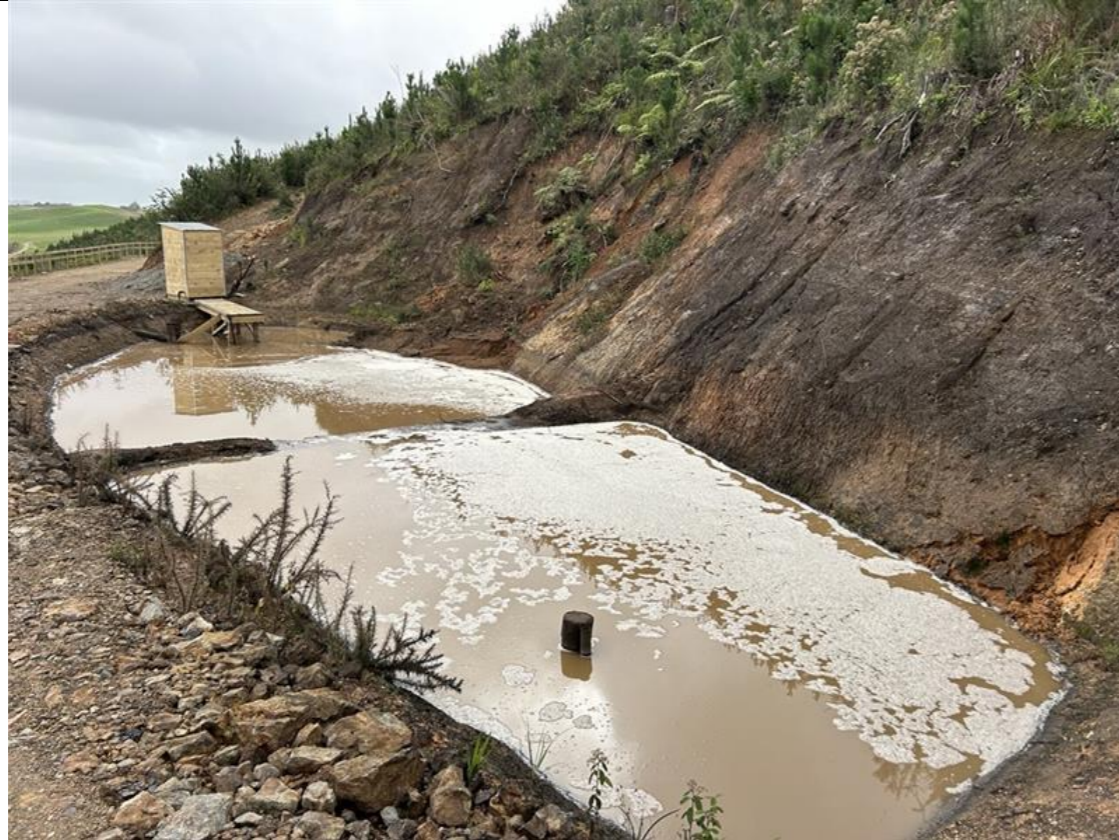
During the site visit, water in the condensate pond was observed to be brown, murky and turbid, with foam buildup noted around the edges. Black staining, possibly associated with the “hydrocarbons seal” noted in the “Condensate Water Discharge Report – Mt Pokaka Timber Products Ltd”, prepared by PK Engineering (refer Section 3.4), was noted on the spillway between the bays. The site representative was not aware of a hydrocarbon seal having been installed in the condensate pond but advised that a sediment filter is proposed to be installed to the northern end of the condensate ponds in the near future.

Photo 17: Northwest-facing view of the condensate pond.

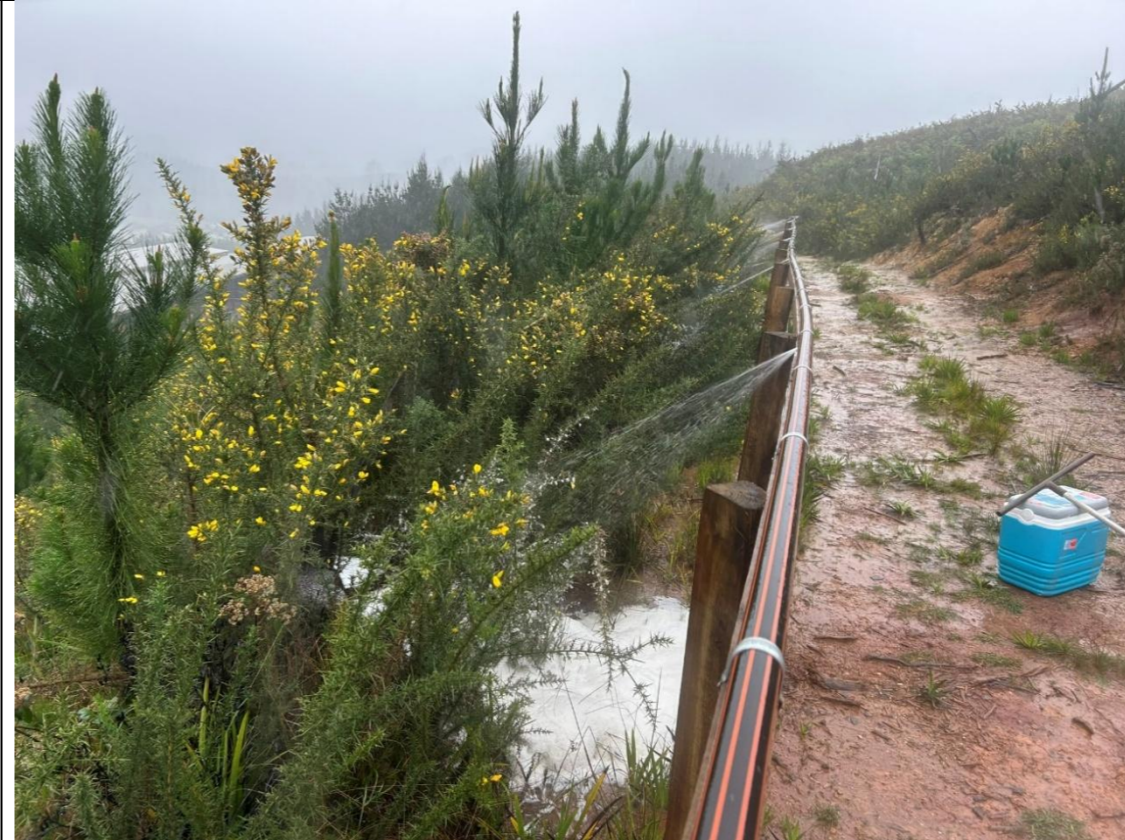
At the time of the site visit it was noted that two sectors along the discharge field were active. Considerable buildup of foam was observed below the discharge points, flowing out of the lower end of the discharge field and in the drain running along the uphill side of the track along the lower side of the discharge field.

Photo 18: Active spraying of condensate onto the discharge field from the drip lines. Foam buildup was observed under discharge points.

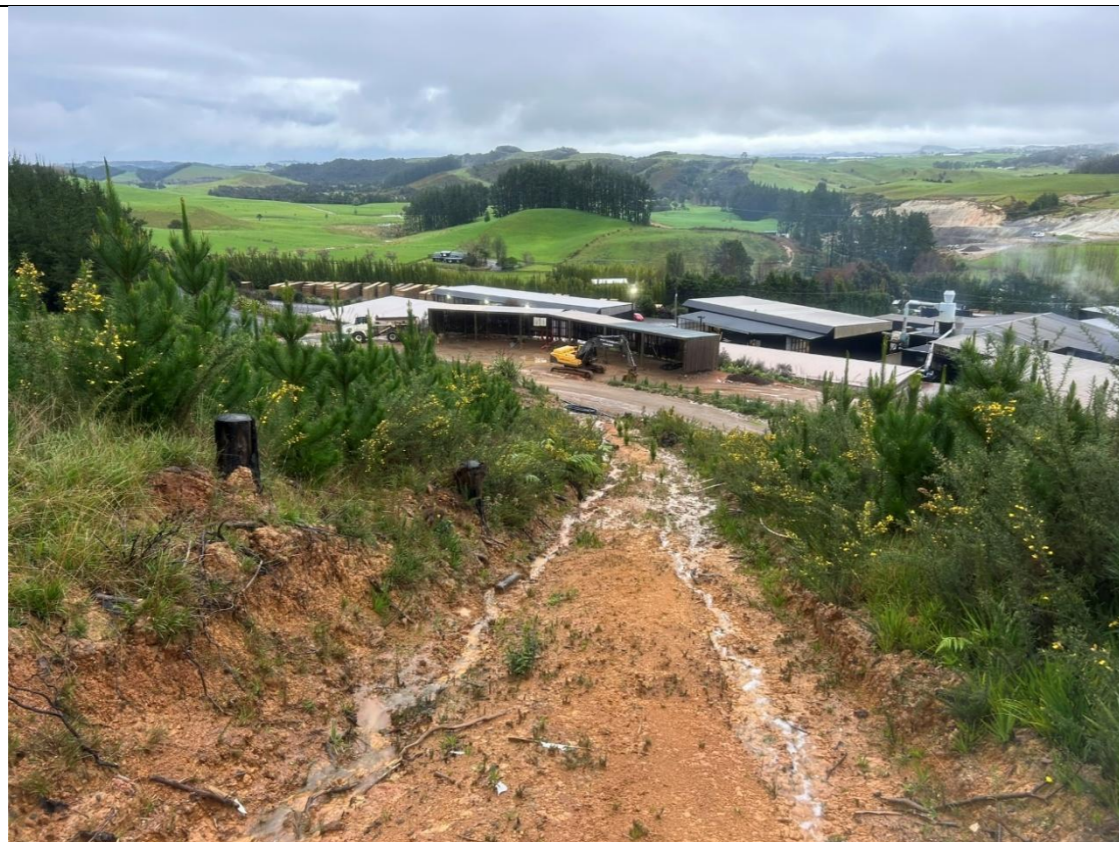
Photo 19: South-facing view of the discharge field. Foamy condensate flows down this pathway towards the Laminata plant and wider sawmill.

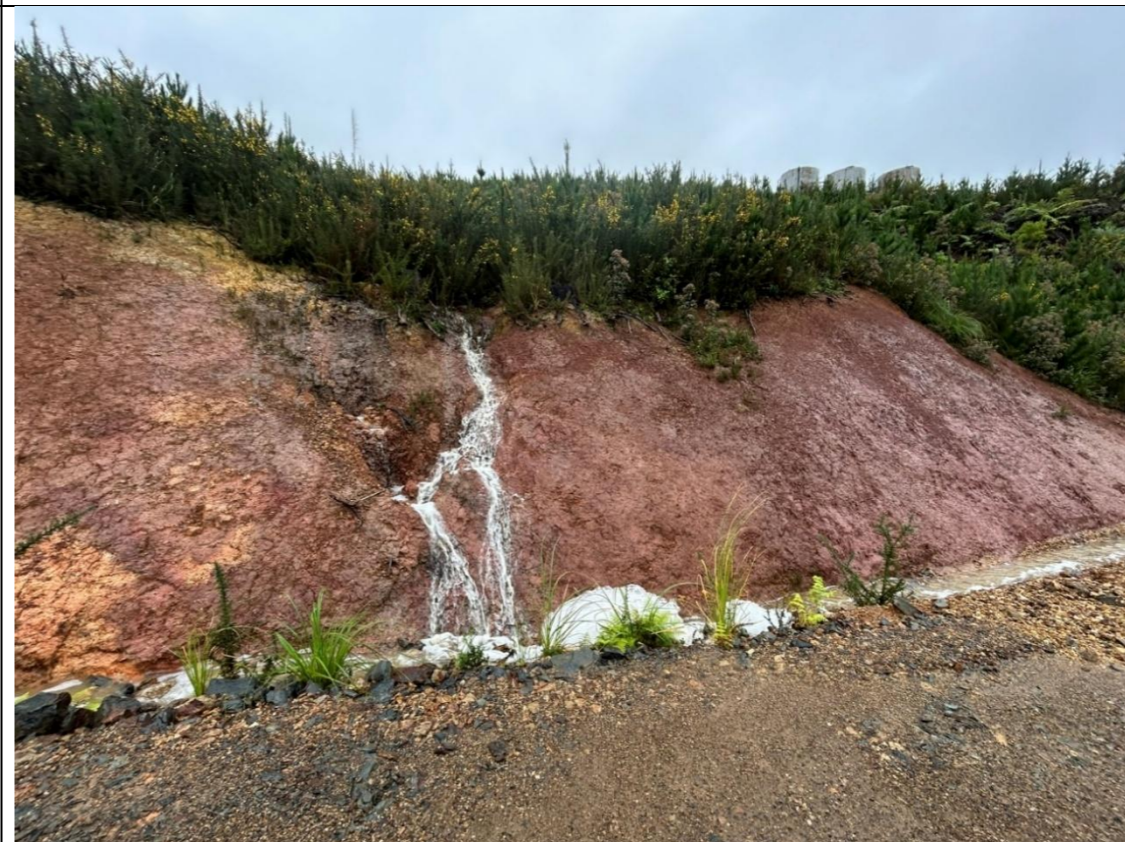
Photo 20: East-facing view of the bottom of the discharge field where significant buildup of white foam is visible. Condensate runoff from the field flows along a channel in a southern direction.
