**FAR NORTH DISTRICT COUNCIL**  
**CONTRACT 7/18/101**

# **Road Maintenance and Renewals Contract**

**MONTHLY REPORT – MARCH 2023**

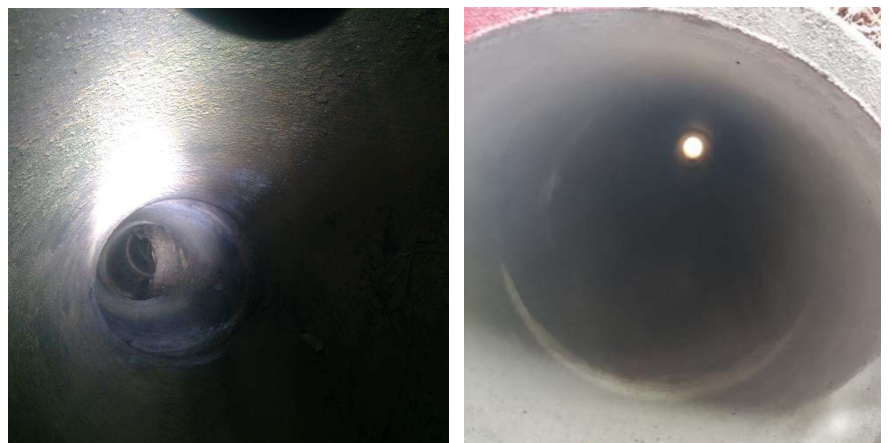
Oromahoe Rd RP7928. Out with the old in with the new. Daylight can be seen again. A badly shifted culvert replaced. Left (Before), Right (After)

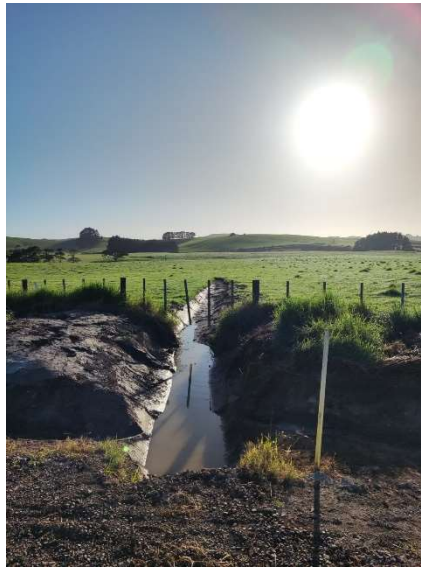
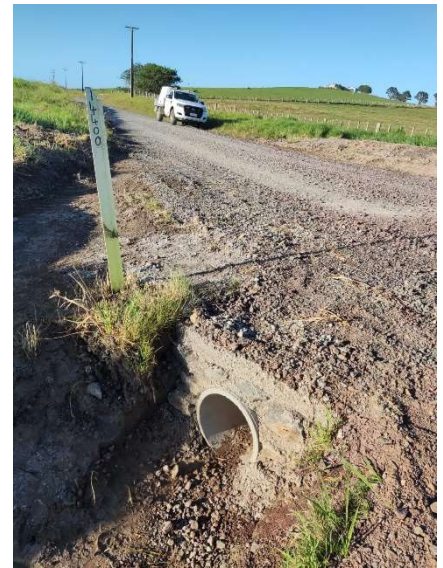
Purerua Rd RP14400 – Installation of new culvert, inlet headwall and daylighting into the paddock.

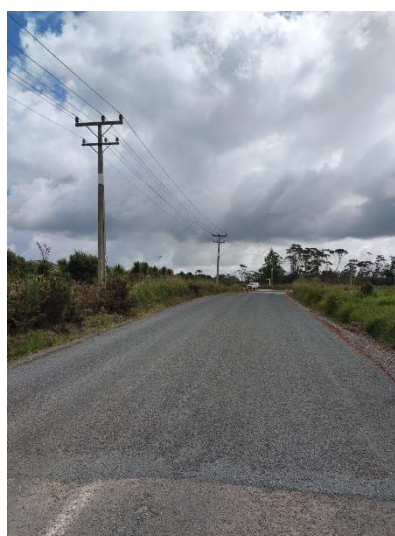
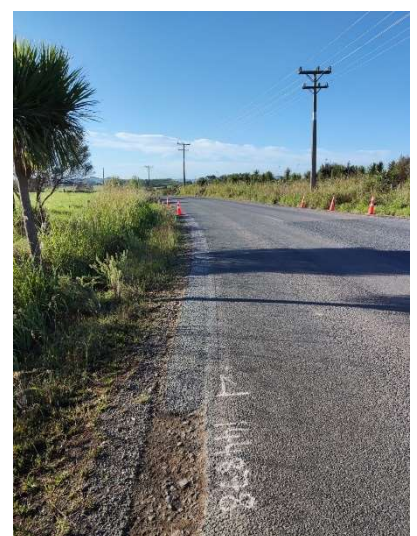
Most of the ordered works this month were just clean up type jobs but some significant works were completed on Waimate North Rd. Dig outs and stabilised patches completed on a section of road that was significantly failing.

Also trailed edge break repairs with basecourse build up then sealing over rather than the less permanent method which is plant mixing.

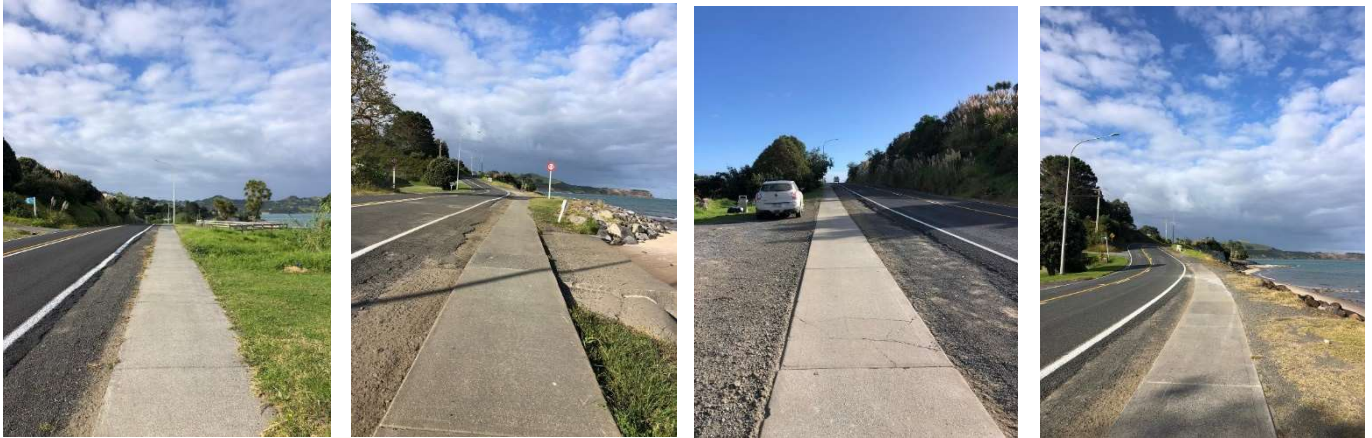
We carried out a lot of grinding on trip hazards across the network, in particular a large job at Tii each in Paihia. The concrete team has been working on renewals in Kerikeri. While at present the footpath team is in the BOI ward, we have been carrying out maintenance activities in Omapere and Kaikohe recently around vegetation and debris. Some pictures showing completed path sweeping out West.

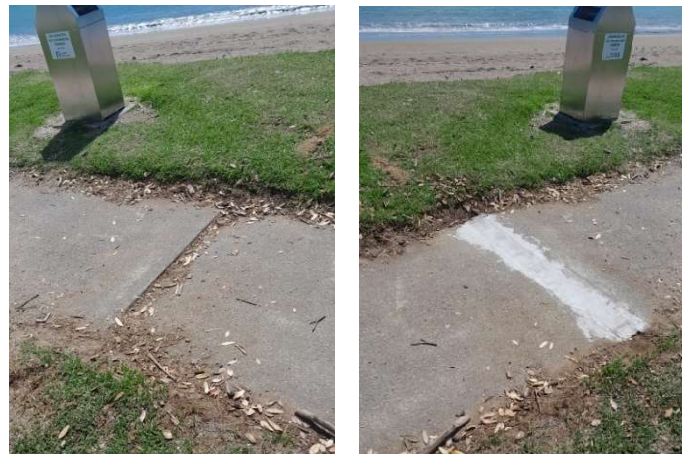
Footpath trip hazard repairs along Te Karuwha Parade. Cobbles have sunken so rather than remove and reinstate to have them settle again an alternative was carried out involving quick patch epoxy mortar repairs. Note the colour will fade in time and blend in.

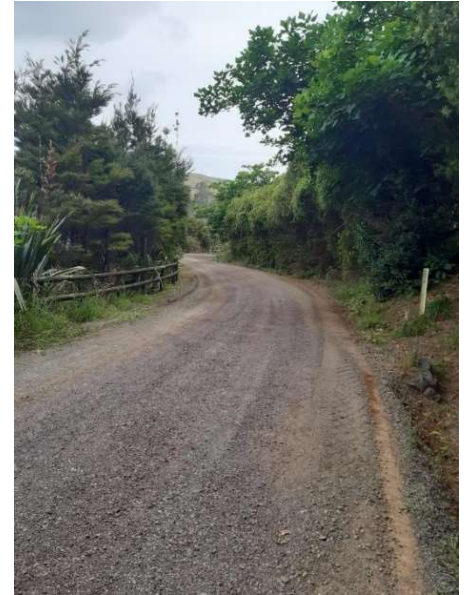
Approximately 1231m<sup>3</sup> of running course was applied to numerous roads across the network including Roger Rd, Montrose Rd, Curtis Rd, Ngawhitu Rd, Wellsford Rd and Punakitere Rd.

*Takou Bay Rd – Running Course*

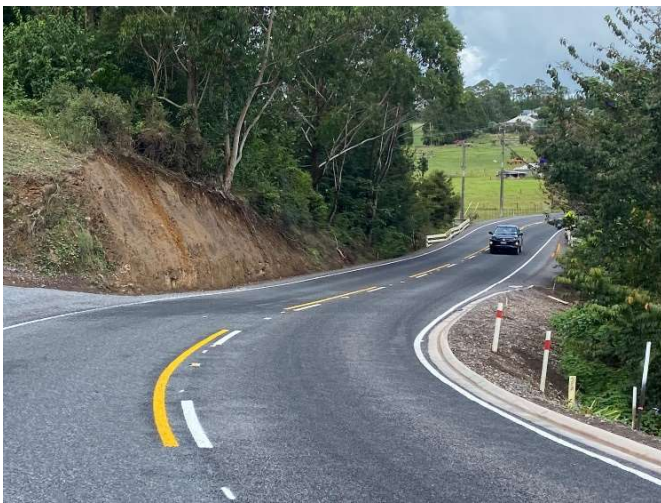
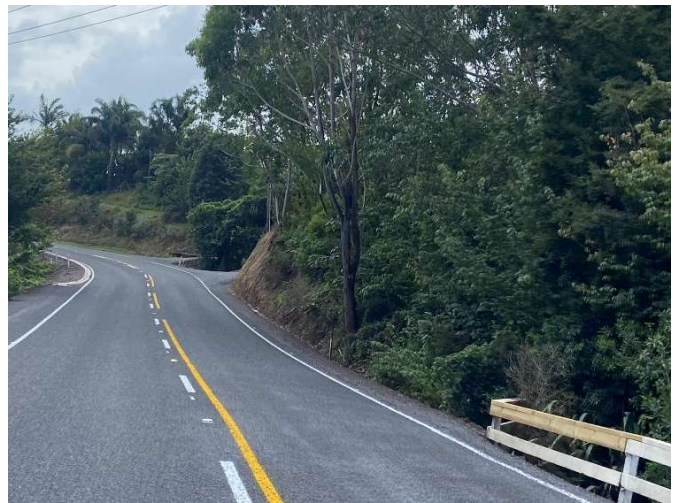
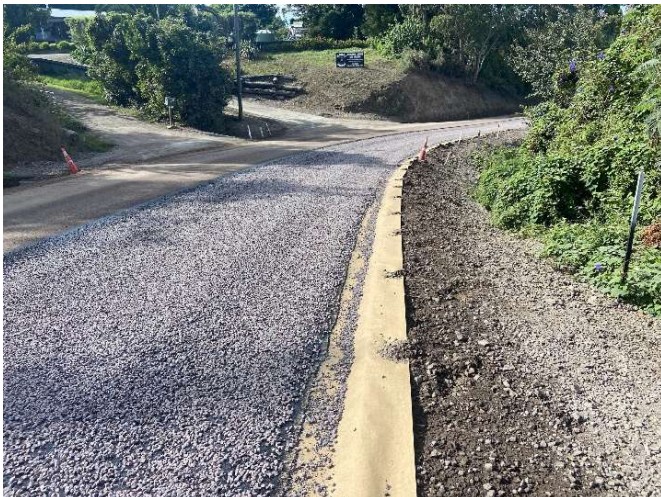
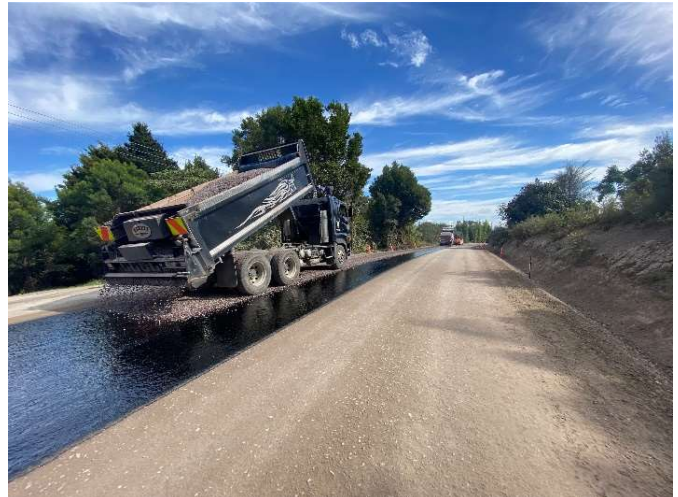
### Waimate North Rd

Waimate North Road was stabilised and sealed late Feb and line marking followed through. The team have moved to Ngapipito Road Rehab and will continue with drainage works (Culverts, Manholes, and subsoils) for the next 3 weeks. The team moves back onsite after winter to commence with shoulder checkouts and overlay.

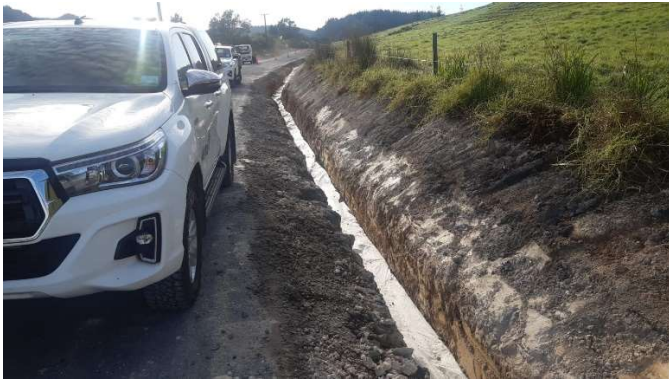
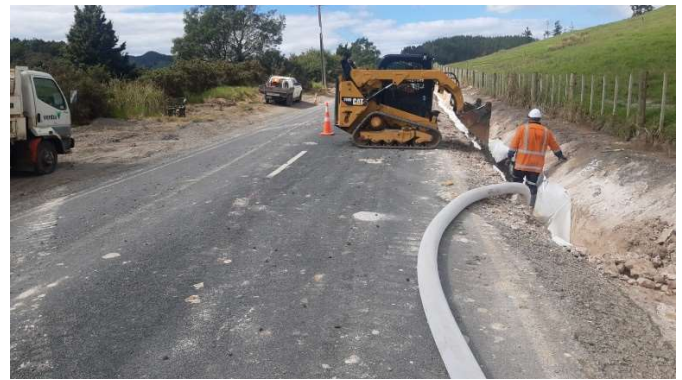
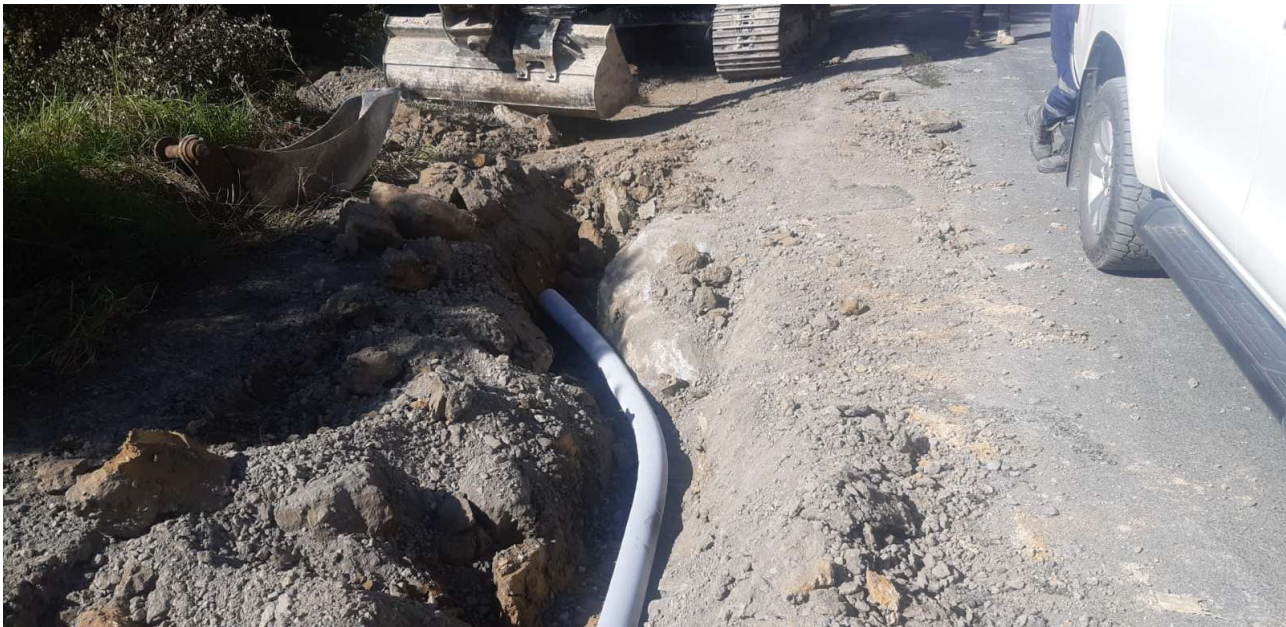
## Ngapipito Rd

The team are laying over 2060m of subsoils along this rehab and came up with a great innovation. Using a bobcat to load the drainage material in rather than larger machinery like a loader or digger. This has greatly improved productivities and safety around the machinery.

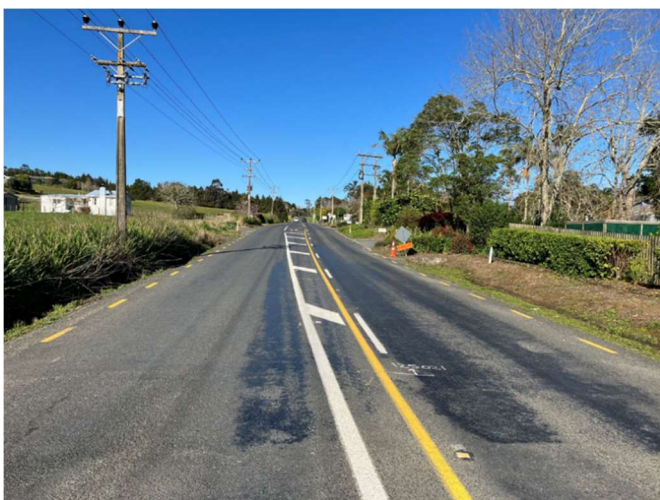
This is an example of the benefits to resurfacing our local roads. The Macro Texture (road surface texture) on Waimate North Road has improved due to the elimination of the existing flushing.

***BEFORE Photo (Taken at Preseal Inspection)***

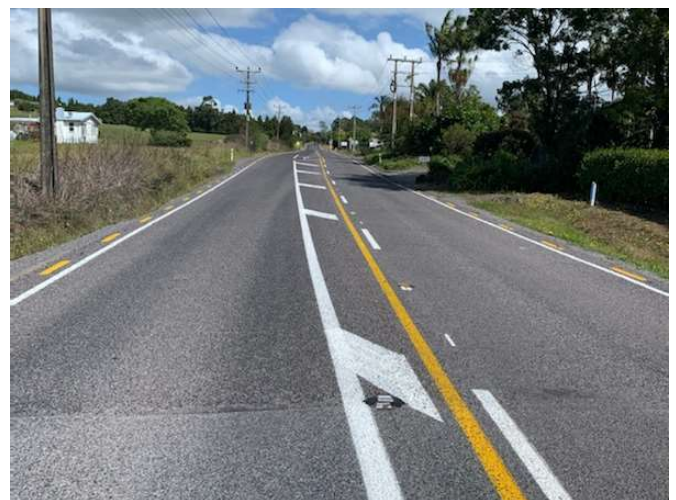
***AFTER Photo (Taken after Resealing)***

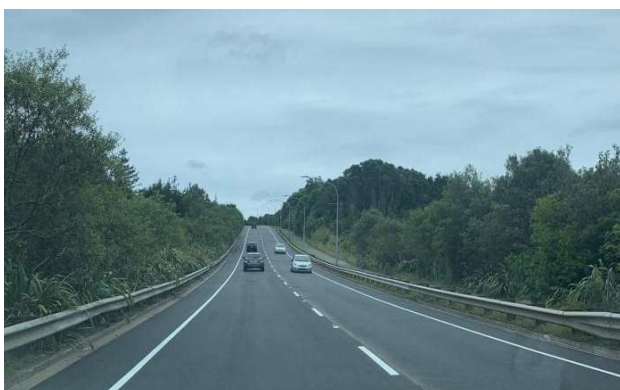
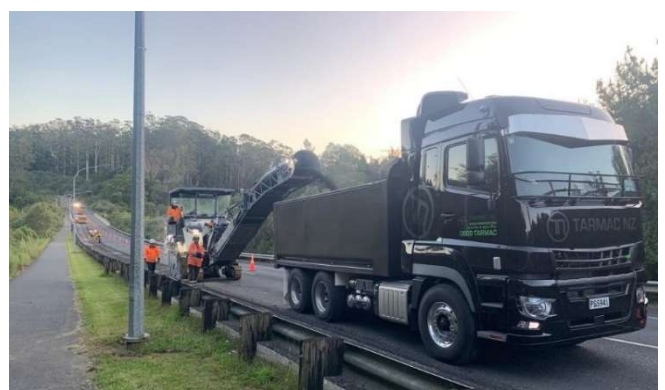
Site 1 of 2 Asphalt sites was completed in March on Heritage Bypass Rd. Site 2 is booked for April on Tau Henare Dr, a single shift job then all Resurfacing will be completed for the season.

On Heritage Bypass 650tn of 15-year-old asphalt was milled out and replaced as mentioned further up in this report. From a **sustainability** point of view milling out that much material and just throwing it in a cleanfill or landfill is not ideal. We have found it to be very useful to repurpose on private driveways or races in the past and have a few ideas around bridge approach infilling that we would like to trial instead of spending money on chip sealing and requiring more maintenance long term. But in the meantime, some of the material is going to be used on Waimate North Rd in the deep swale at SH10 end in the next month. It has good binding properties on slopes and hardens up over time as the bitumen reactivates a little bit to glue it back together after compacting. Photos to come of this in April.

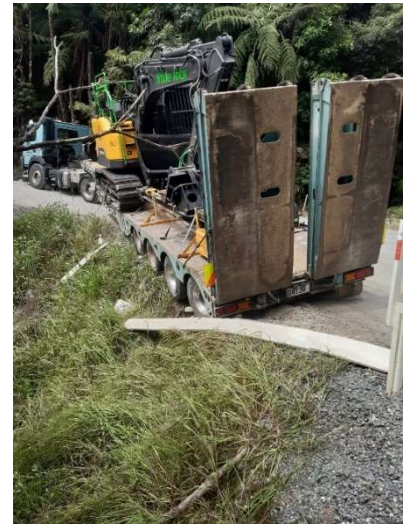
There was also a large transporter attempting to navigate Waikare Rd, in the process getting stuck on one of the very tight bends. Even hard to get around in a Ute at times. We set up a temporary closure for 3 hours and luckily the crane managed to get the transporter and brand-new digger back on the road safely.

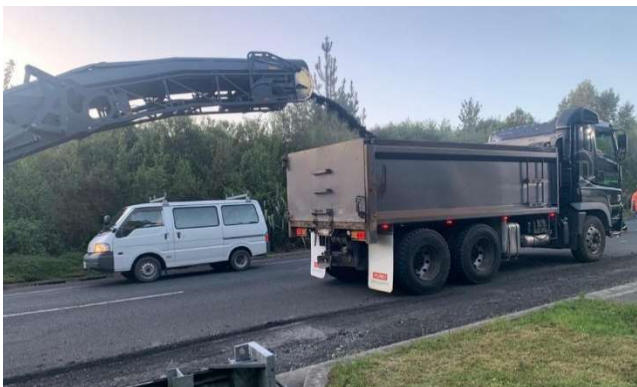
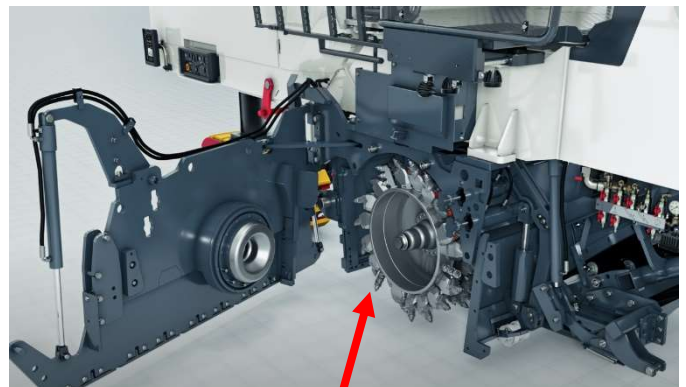
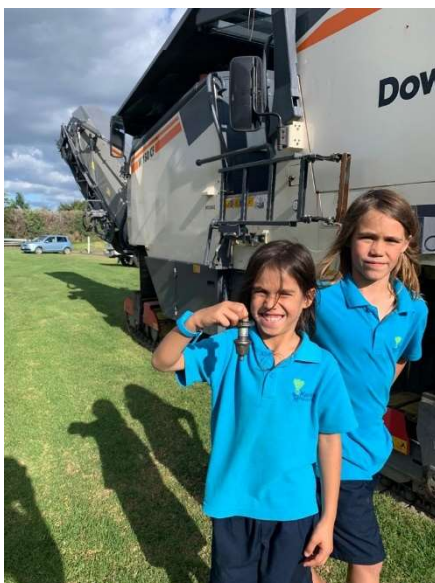
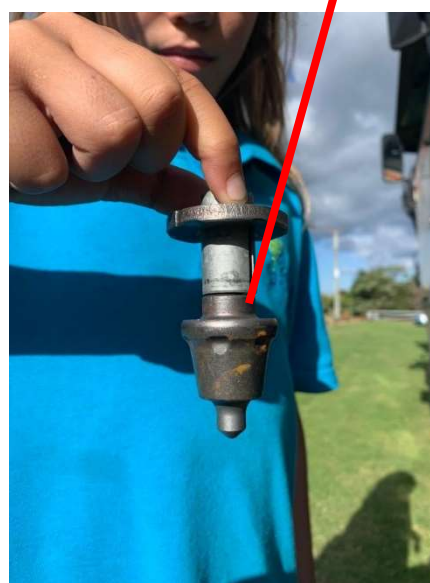
Below thanks to my boys Boston and Tommi for modelling is a miller (road profiler) tooth. These are on the drum of the conveyor machine also pictured. The tip is made of Tungsten Carbide as the road profiler drum spins at between 150-250 revs per minute destroying what's in its path. A seriously cool bit of kit.

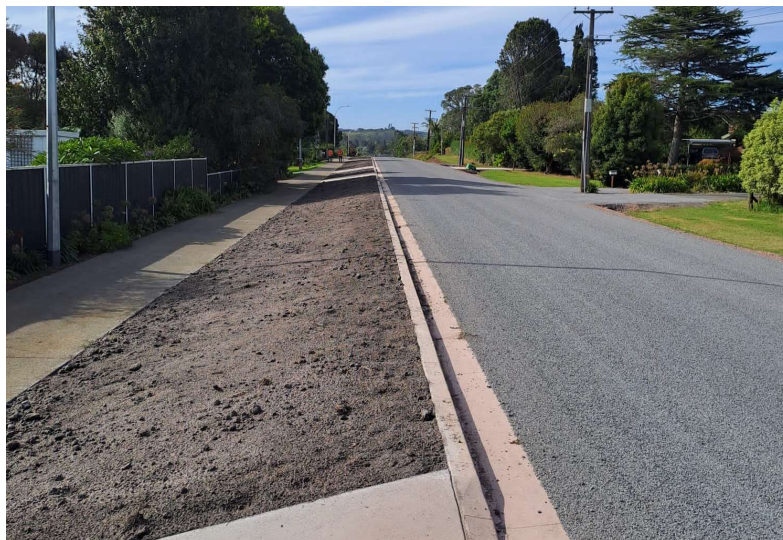
1. Hall Road Upgrade – Arvida – Practical completion on this project have now been achieved with only the line marking to be completed in the first week of April. We received a lot of praise and thanks from all the residents and client alike. The road had been widened and sealed to a 6.5m sealed width and is a big plus for the Hall Road residents and Kerikeri community.

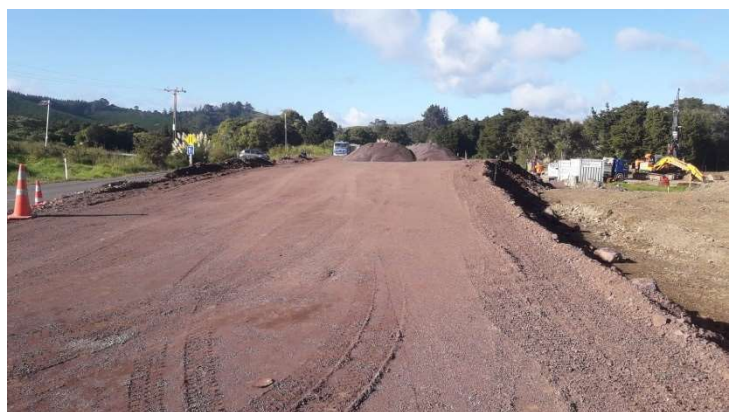
2. Pokapu Road Bridge Construction – the team are excited to be a part of this project and we started with the piling works on the 16<sup>th</sup> of January. The piling is  $\frac{3}{4}$  complete with Abutment D and Pier C and B Piles poured. The bridge approaches have also been formed with the hard fill on both the North and south sides now in. Still a few months to go on the project. The bridge concrete structure will go up over the next few months before we start with the pavement realignment in August 2023. Watch this space for some photos.

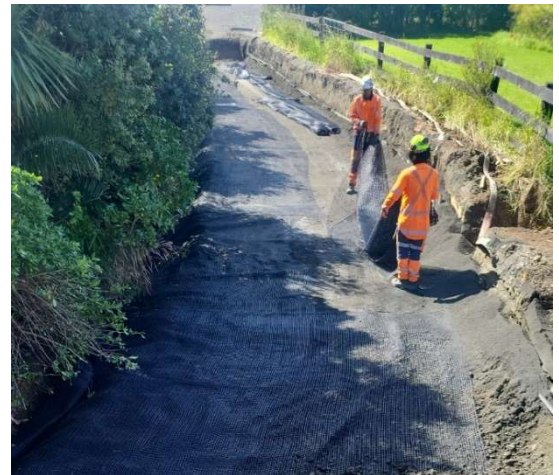
4. Tahuna Road, Kaitaia – the team have worked on this road slip repair in Kaitaia. The road and driveway slipped into the stream, and we have used Geogrid to create a steep batter and reinstated the road and driveway by wrapping the Geogrid in layers with GAP65 hardfill. Installed some positive drainage and gave access back to the residents.

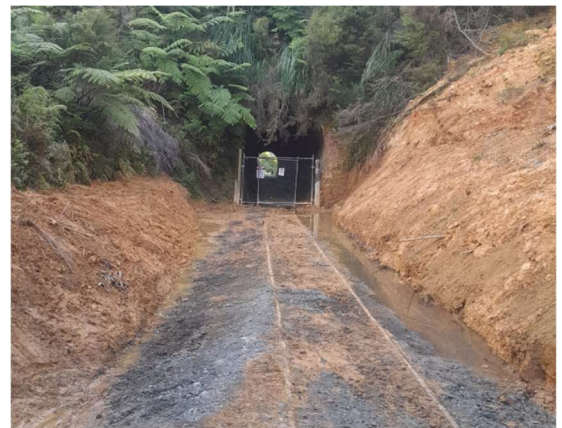
5. Cycle Trail tunnel overpass – We have been engaged to repair the surface of the tunnel overpass on the Twin coast cycle trail. We had to clear a big over slip from the track before we can start with the installation of wooden gates in front of the tunnel to prevent people from cycling through the tunnel.

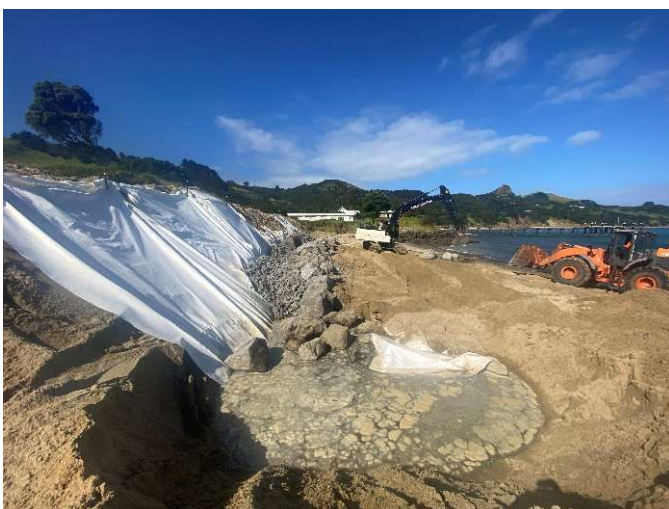
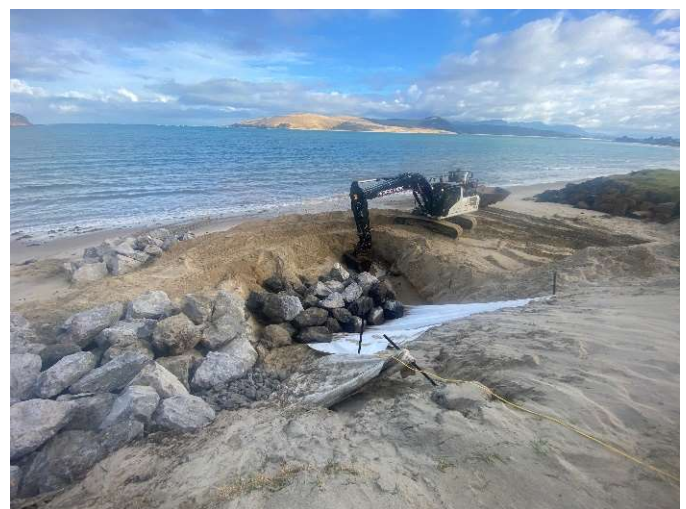
6. Freese Park- Seawall – Construction team are doing a 120m seawall construction on Freese Park in Omapere. Seawall is 80% completed with Redirock blocks to place in the next 2 weeks.
