## 1. SUMMARY

# 2. WORK PROGRAMME

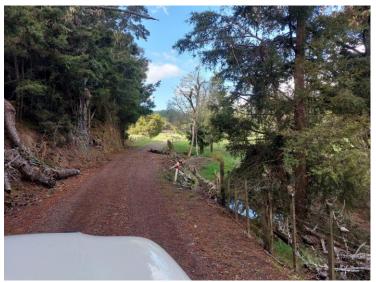
The only emergency work was a result of the potential weather event on the 12<sup>th</sup> April. We received more than 50mm of rain in some areas however the only damage was minor trees down on Owae and Ruapekapeka Roads.

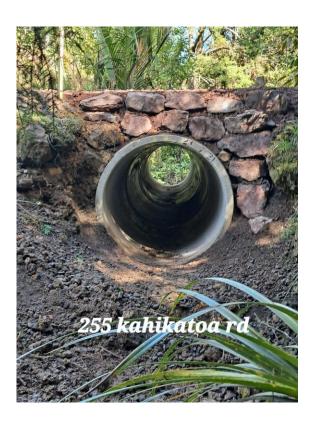
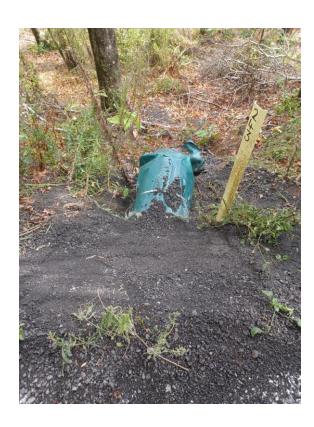
Rays team completed urgent culvert replacements on Kahikatoa Road and Lake Road that have been causing issues recently. They have also replaced culverts on Wharepunga Road in conjunction with the recent unsealed rehab work. They'll head south in the next few weeks, to address more problematic areas as we head into winter.

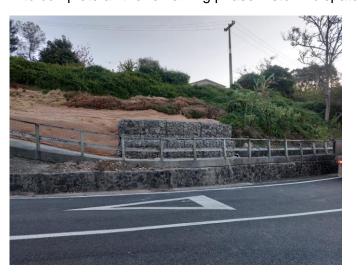
Darroch Contracting completed a recurring slip area on Ruapekaka Road that continually spills debris out onto the footpath. They also finished a small underslip on Waiotemaroma Gorge Road. We are on track to complete all the remaining phase 2 storm dispatches by the end of June.

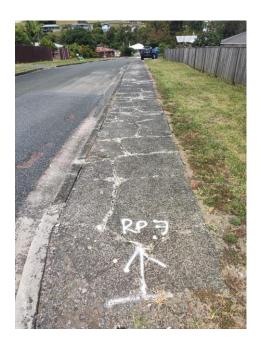
The concrete crew have completed most of the programmed renewals in the eastern ward. They are now working in Kaikohe. In between jobs the team has also cleared a lot of overgrown kikuyu grass off multiple footpaths around Kaikohe.

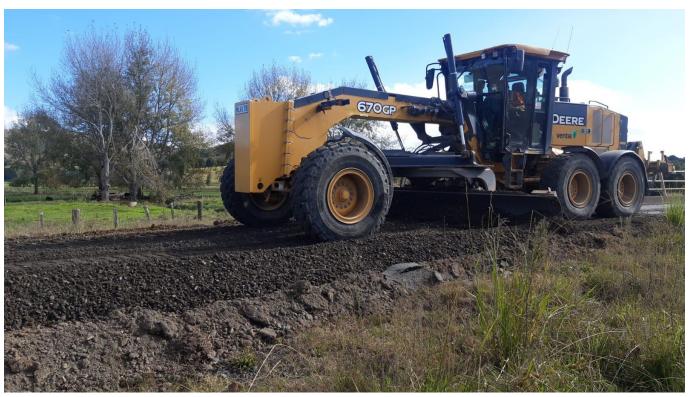
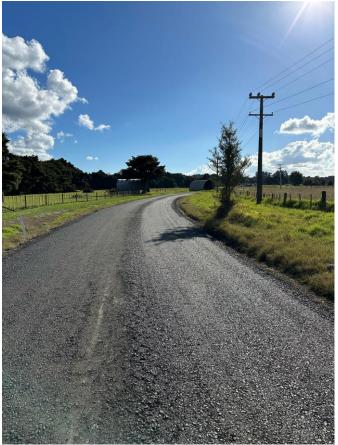
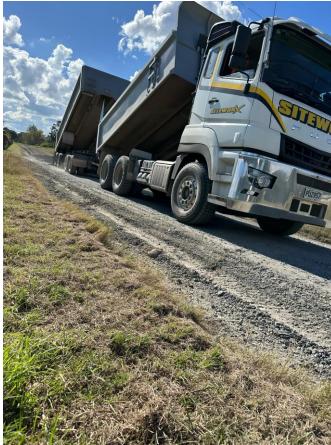
- Okaka Road RP1306-1578. Road received 320m3 of new aggregate to lift the pavement of a flood prone area.
- Mangatawa Road RP 716-2190. Wearing course totalling 1000m3 aggregate.
- Otaua Road RP 80-5137. Wearing course totalling 3230m3 aggregate.

Fun Fact – A wearing course consists of approxamitely 100mm of compacted Gap 30 aggregate to increase serviceability of the pavement and provide material for graders to reshape the road. This aggregate is generally smaller in size compared to the material used for pavement strengthening. Running course is a sacrificial layer up to 30mm thick of uncompacted Gap 30 aggregate and is used to fill the voids of larger aggregate.

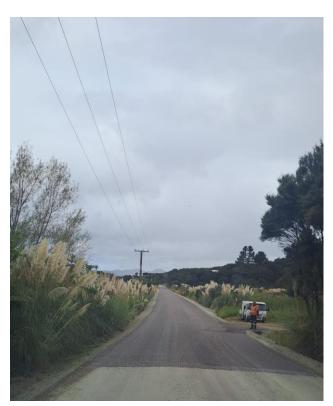
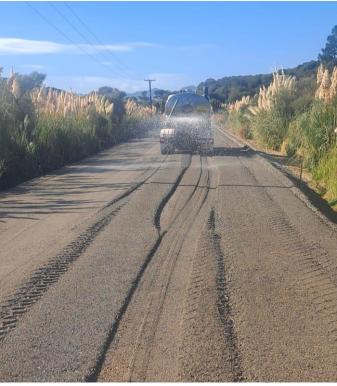
## 1. Paroa Bay Road

Paroa Bay Rehab was finished early in the month. This job was surrounded by tidal swamplands, with the full moon tides bringing extra high sea levels.

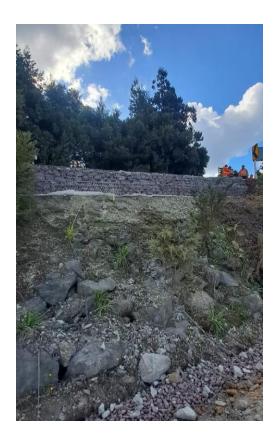
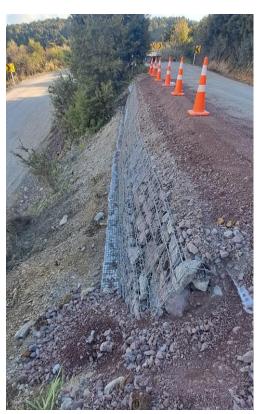
## 2. Hautapu Road

Hautapu Road Rehab got underway in April. We started the enabling and drainage works, and completed a terramesh basket retaining wall. Works will continue on this site in May, however the sealing will get deferred to next season as the temperature will be too cold when stabilising is complete.

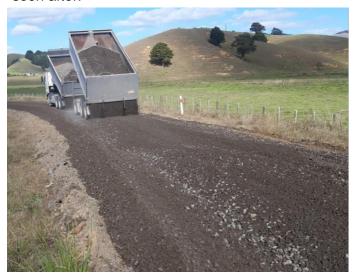
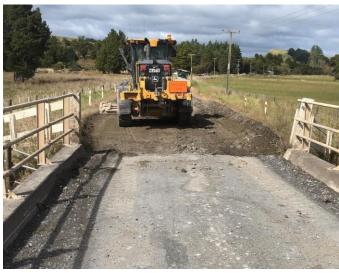
## 3. Orakau Road

Orakau Road bridge approach sealing got underway In April and consists of the sealing of 11 bridge approaches – 50m either side of each bridge. These bridges have been an ongoing concern in the past with potholes, rutting and drainage problems. Stabilising is booked in for the 8<sup>th of</sup> May, followed by sealing soon after.

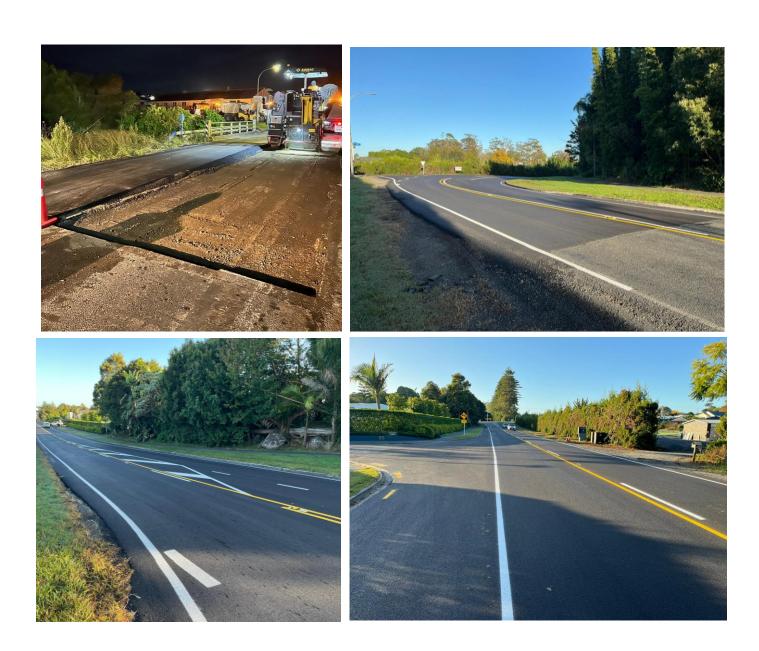
In late April we completed the Asphalt resurfacing of Cobham Road in Kerikeri. This project involved approximately 10,000m2 of surfacing works along with some additional drainage and shoulder works down towards Kerikeri Inlet Road. A great new asset for the community. See section 25 below for a job where we used the recycled millings!

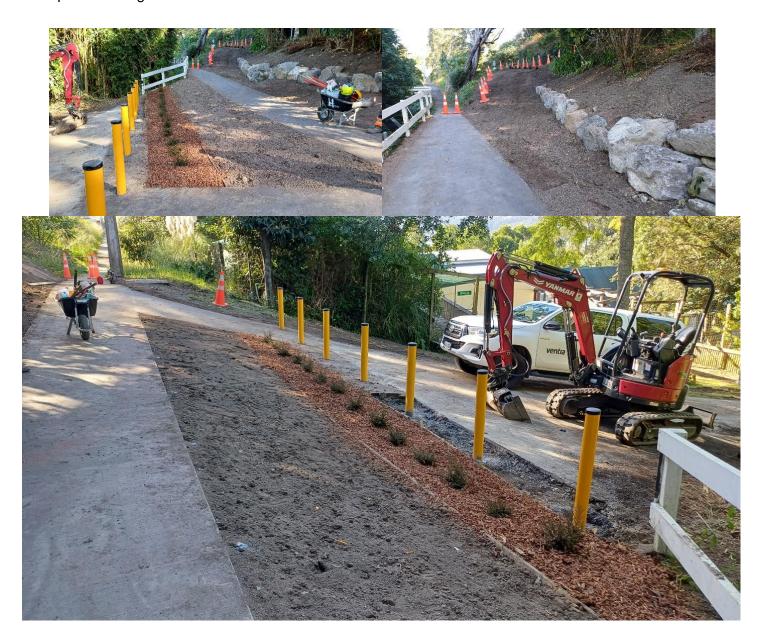
#### Nimmo Street East - Rawene

The footpath project for Nimmo Street East was completed with the aim of connecting not only the existing footpaths for pedestrians but also closing the connecting entrance/exit to Parnell Street. This adds pedestrian protection from traffic and eases vehicle movements on Nimmo Street. Bollards were installed on the topside of Nimmo Street and a planted section of Manuka to give the project a standout look. Extra Manuka were added alongside Parnell as a visual barrier and helped with the aesthetics. An old retaining wall was dismantled and replaced with a new rock wall. Areas above and below the rock wall were topsoiled and grass seeded.

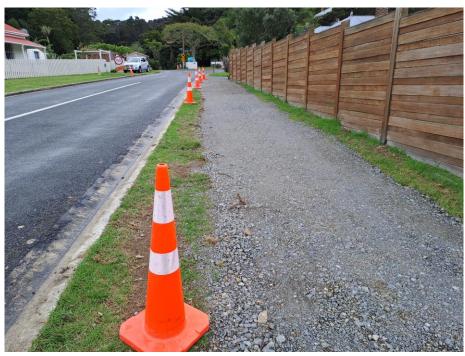
#### Queen Street - Russell

The footpath project has started in Russell with the preparation works underway. New kerbing and footpaths will be installed on all four corners of the Queen Street/Wellington Street crossroads with pram crossings to help with foot traffic. The first concrete pour for footpaths will commence next week.

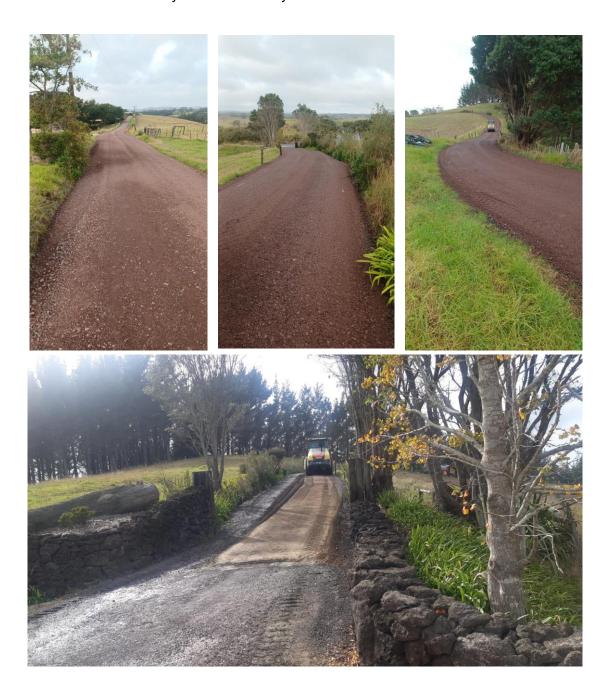
## Purerua Road

This project was for a driveway leading onto private property off Purerua road. A new base was laid and shaped and finished off with a fresh layer of chip seal. Entranceways along the driveway were shaped and rolled in to tie in with the newly sealed driveway.

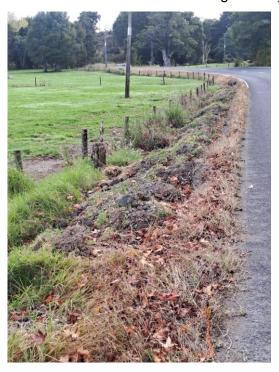
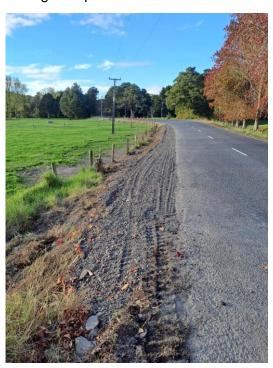
Kawitis team carried out some shoulder scour repairs on Pokapu Road using the recycled aspalt millings from Cobham Road in Kerikeri. Millings are generally acquired when a road is milled up and and replaced with Asphalt or some sort of pavement. The millings are pumped into trucks and taken away to either stockpiles or new jobs where they have many uses. Is this particular example our crew used the millings to rebuild the shoulders which had been significally damaged in previous weather events.
